## The District of North Vancouver REPORT TO COUNCIL

**SUBJECT:** District-wide Landslide Risk Assessment

# Landslide Risk Assessment 2026 Update

Prepared by **BGC Engineering Inc.** for:

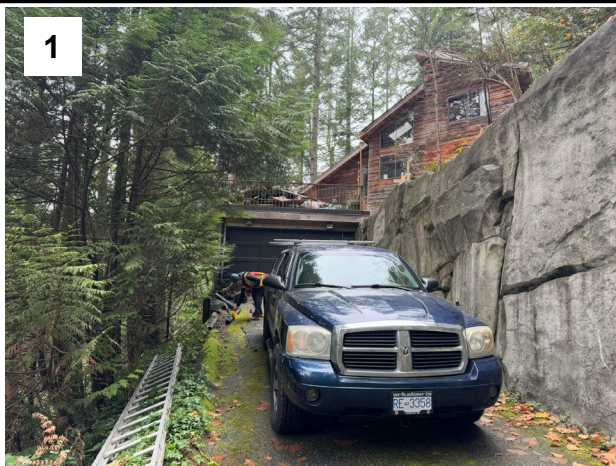
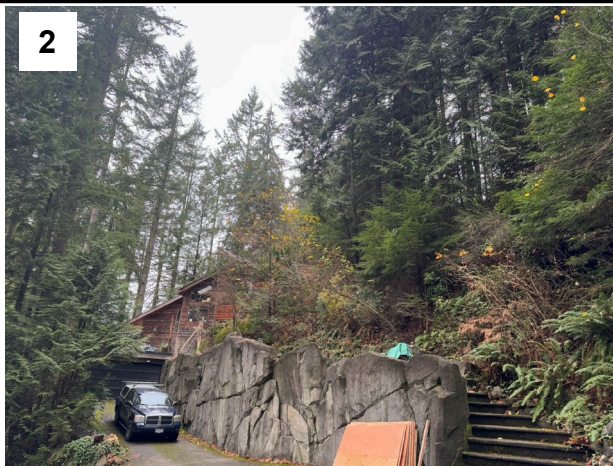
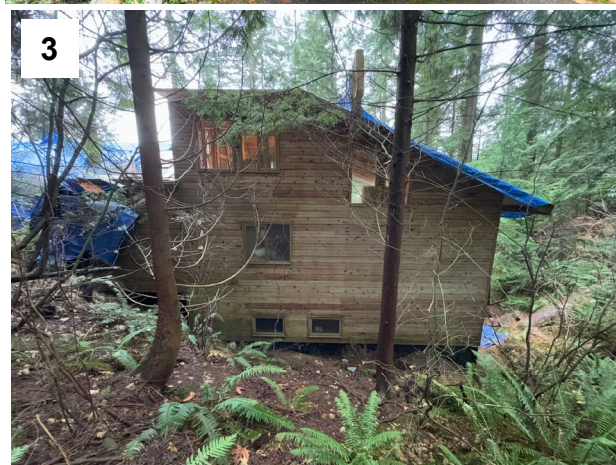
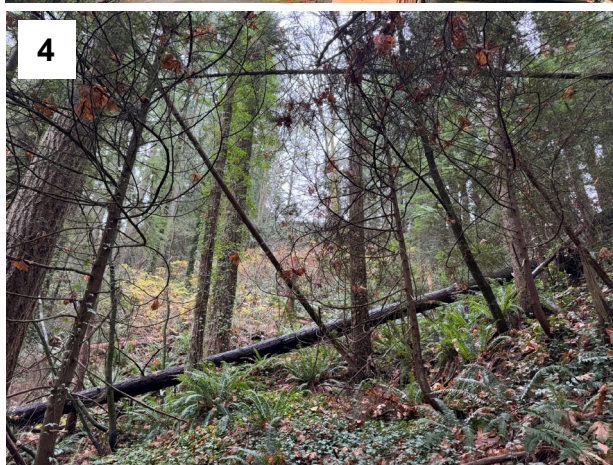
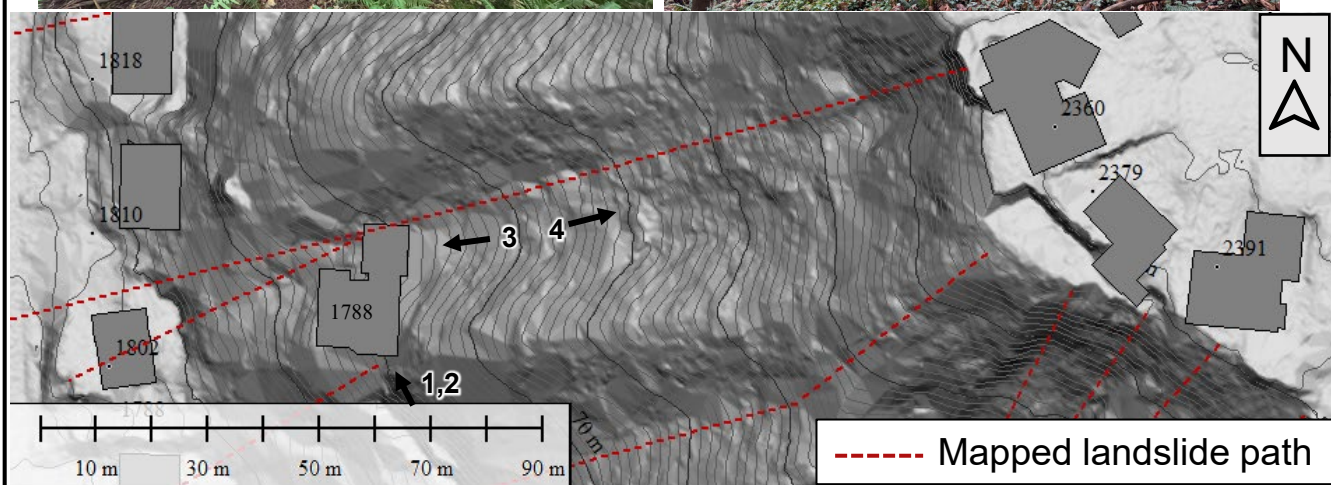
- Cracks observed parallel to slope in driveway. Existing retaining wall at driveway in robust condition.
- Building in natural gully that includes the 1979 slide path. Large conifers observed in gully.
- Northeast corner of building exposed to landslides from 2360 Carman (Photo 3). Southern portion of building footprint protected by ridgeline.

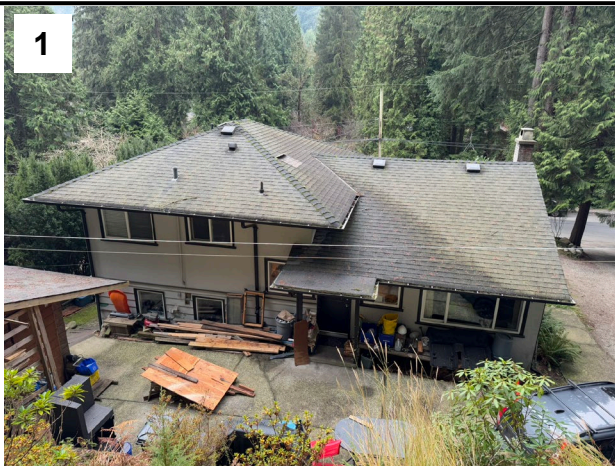
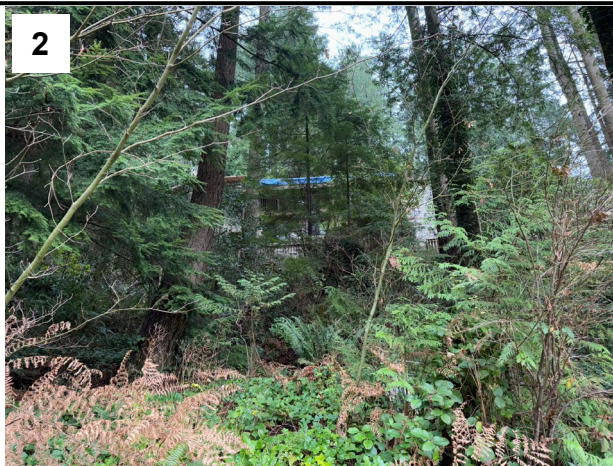
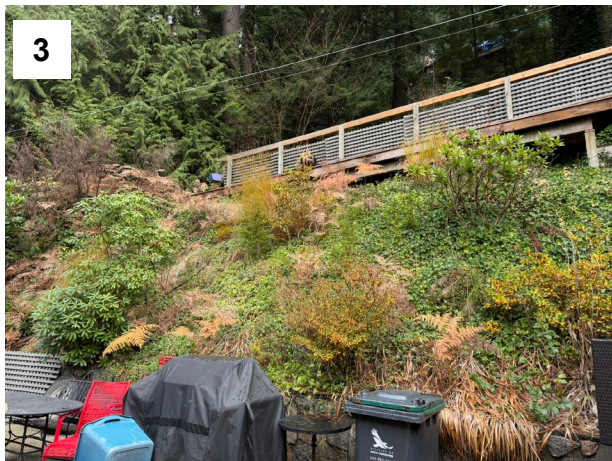
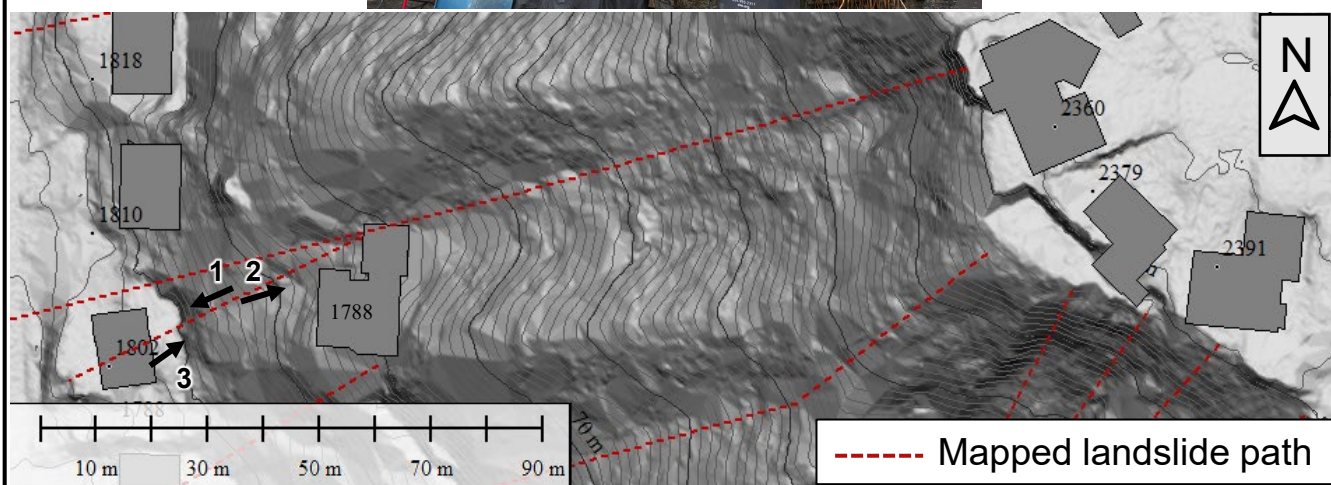
C-2

- Property downslope of 1788 Riverside. Gentler slope upslope of retaining wall.
- Landowner reported having a test pit completed in upslope area and indicated dense material was observed approximately 18 inches below ground (BGC does not have access to log to confirm).
- Landowner reported that stone retaining wall seeps in heavy rain.

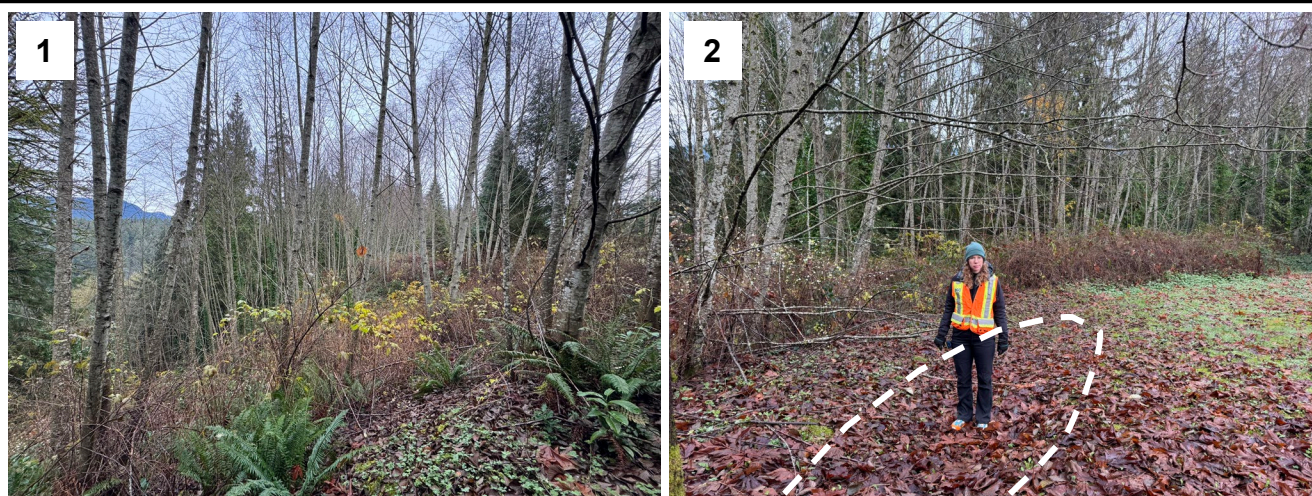
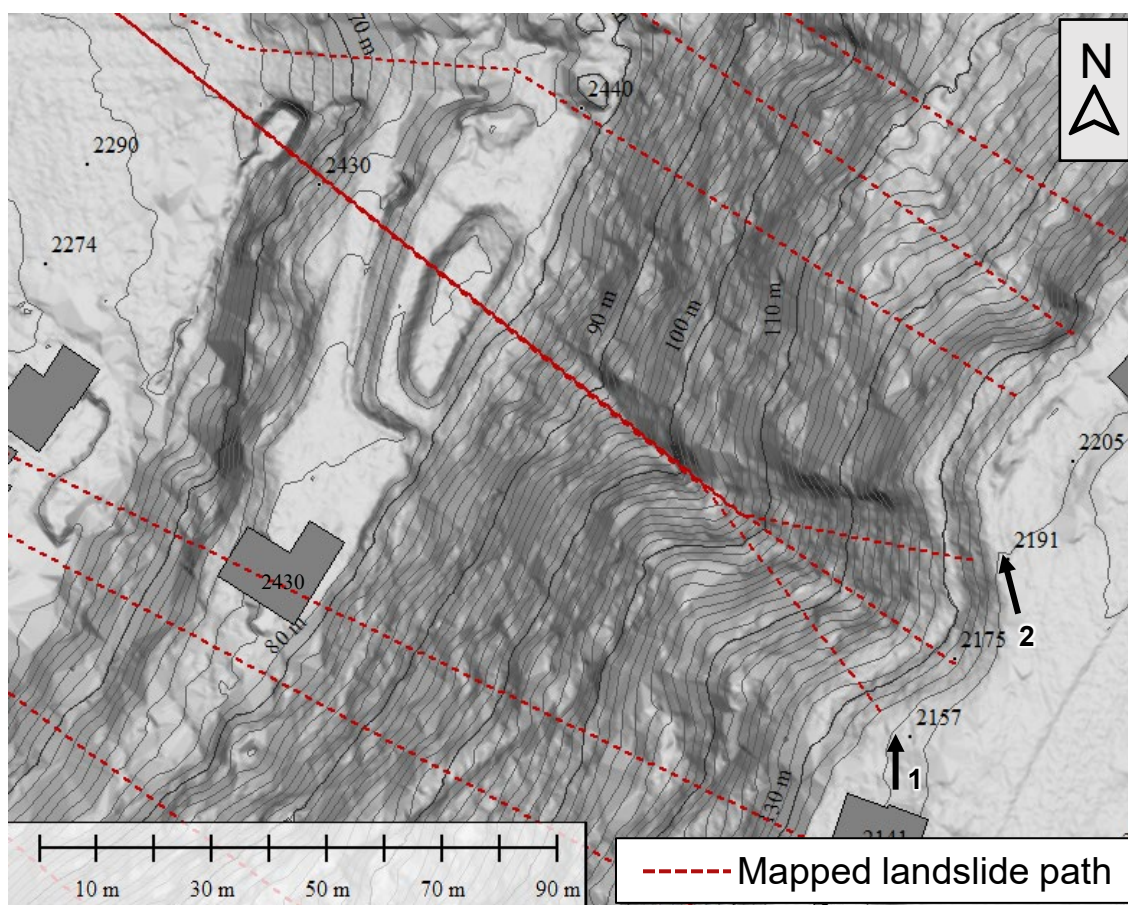
C-3

- 2005 Berkley landslide scarp re-vegetated with alders.
- Minor depression observed behind crest at north side of scarp (Photo 2). No signs of recent movement observed here at the time of inspection.

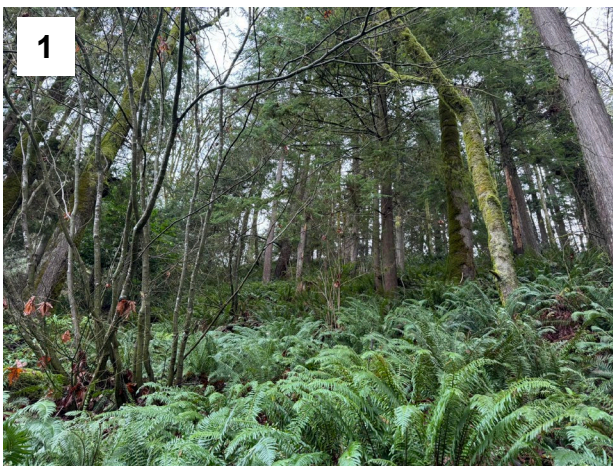
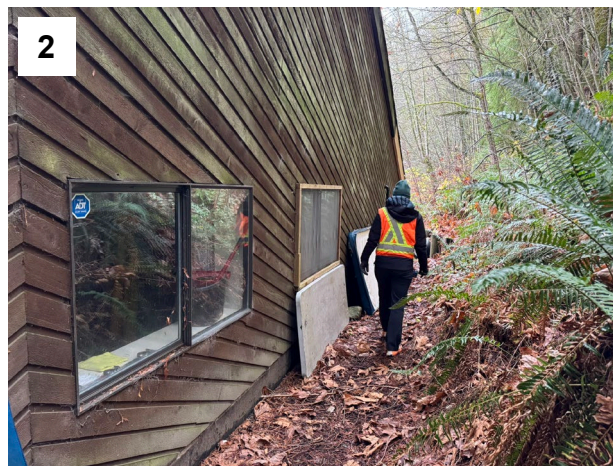
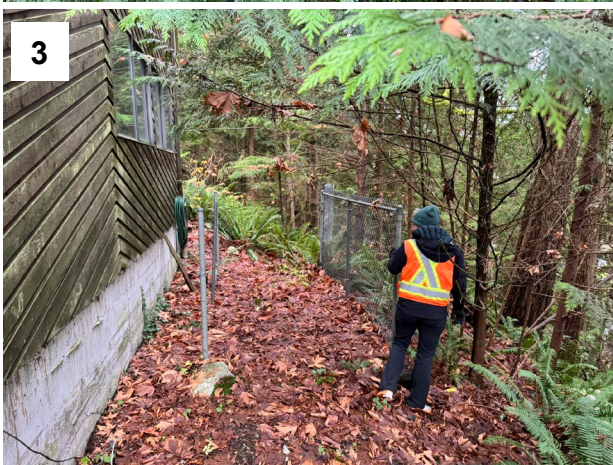
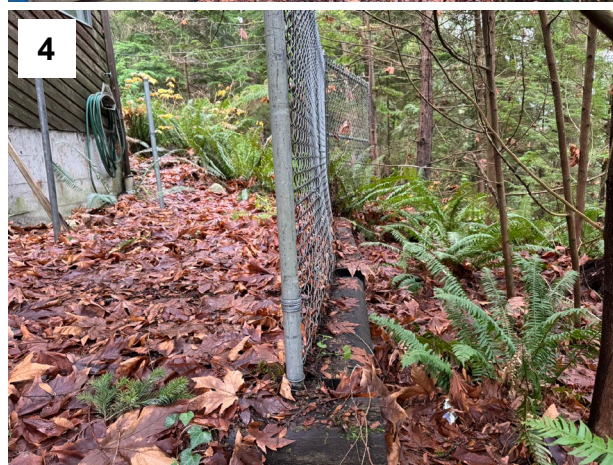
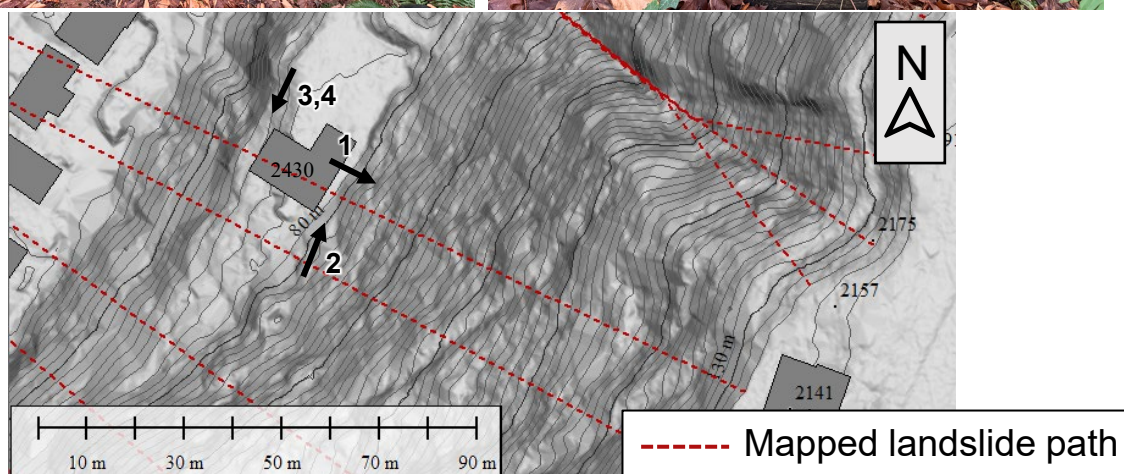
C-4

- Windows near ground level at the rear of the house (Photo 2).
- 0.4 m tall timber crib retaining wall located 2.5 m from the rear of the house and above 13 m tall slope (Photos 3, 4). Retaining wall is bowing downslope slightly. Building downslope of retaining wall is outside of 19° runout angle.

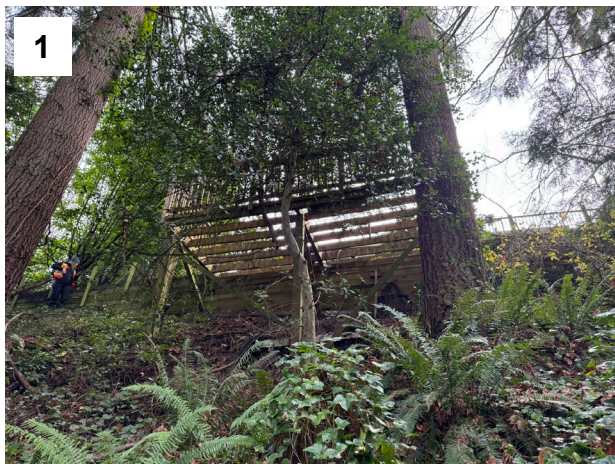
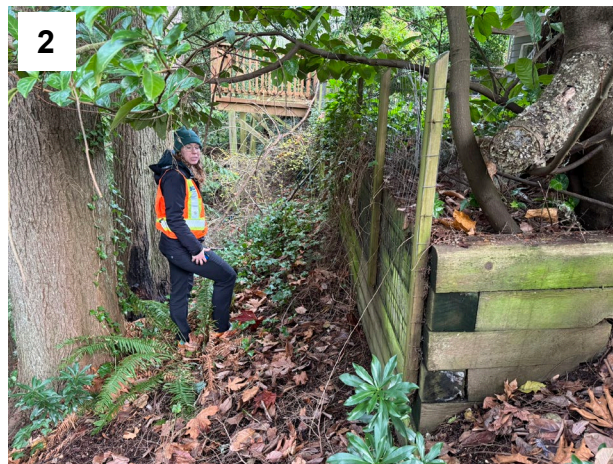
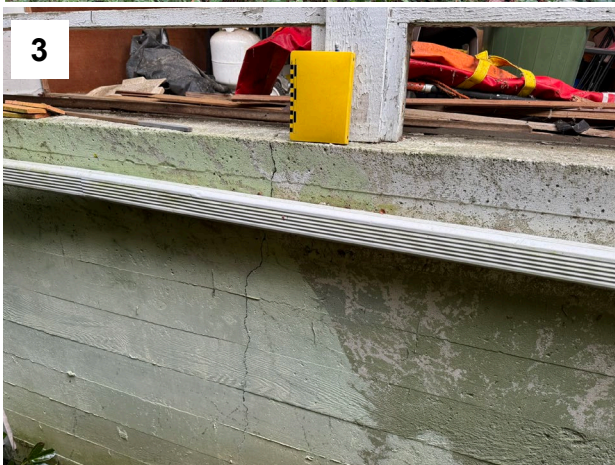
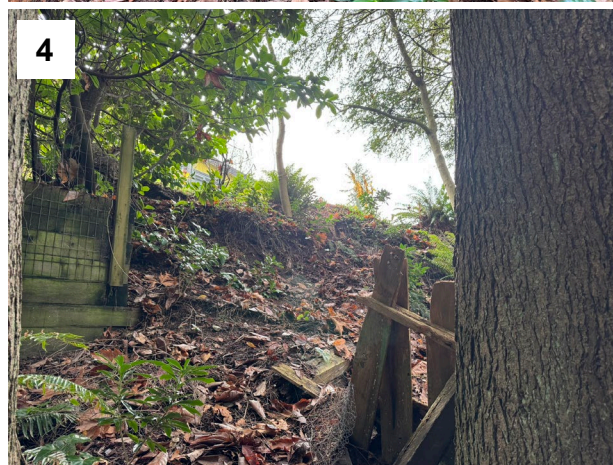
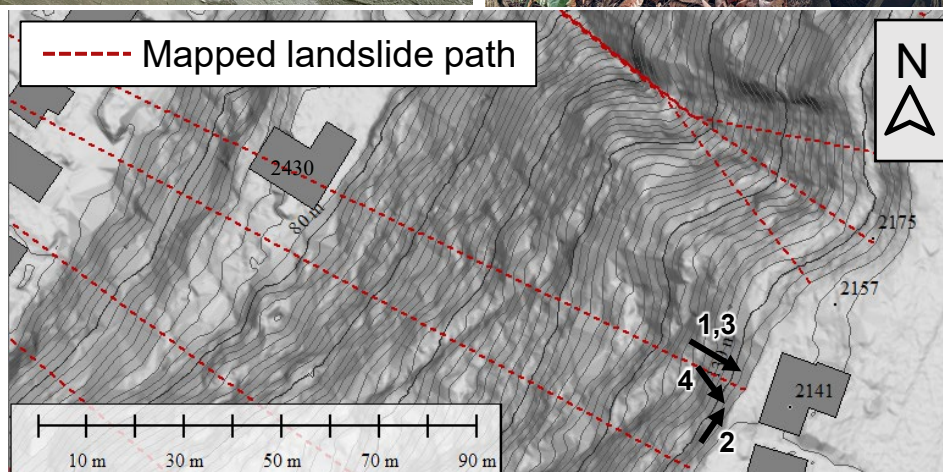
C-5

- Retaining wall in good overall condition at time of inspection (Photo 2). Some evidence of minor tilting and bowing.
- Large conifers on slope are straight.
- Vertical crack observed in building foundation (Photo 3).
- Loose exposed soil at south side of property, south of retaining wall (Photo 4).

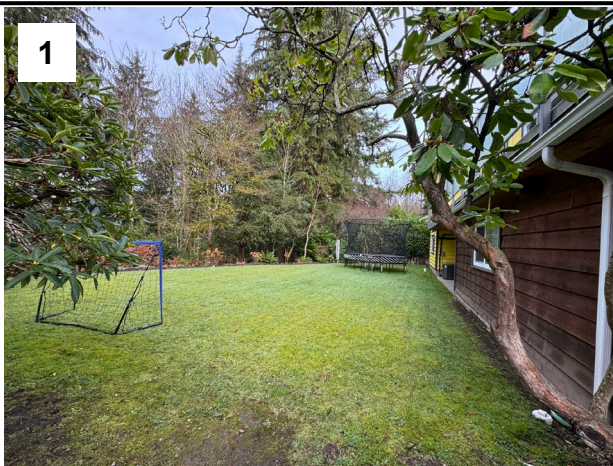
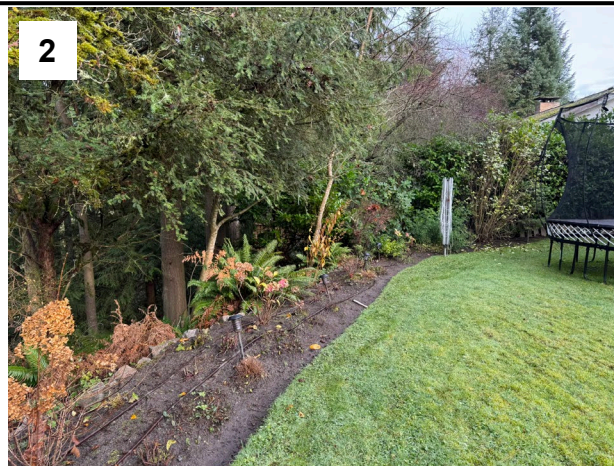
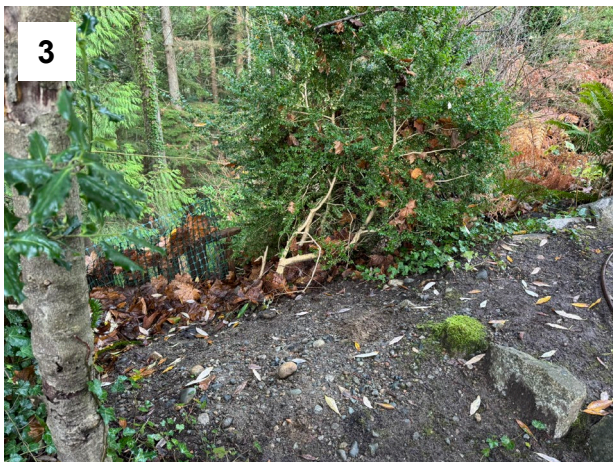
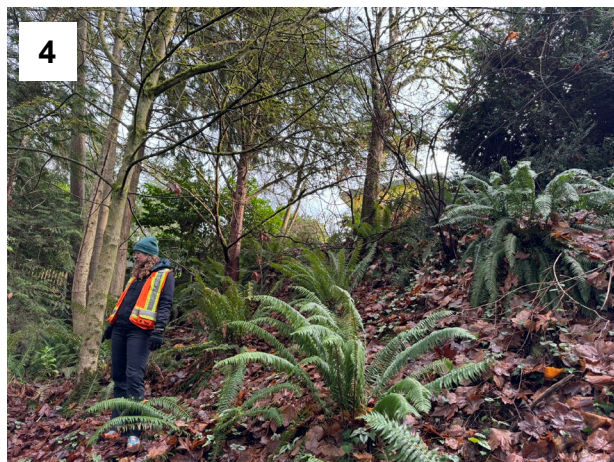
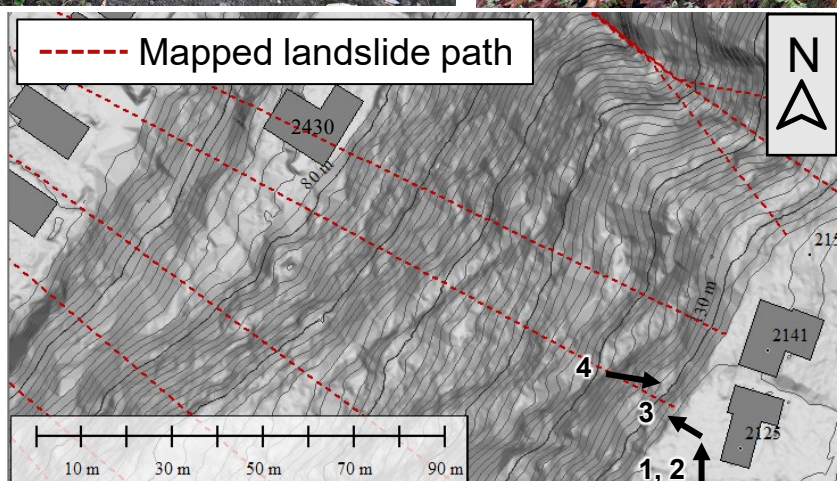
C-6

- Back yard is level (Photo 1). Small depression in grass near garden bed (Photo 2). Garden irrigation at the crest of slope (Photo 2).
- No retaining wall.
- Yard trimmings and loose fill (<0.5 m<sup>3</sup>) pushed over edge of slope (Photo 3).
- Less mature trees compared to slope below 2141 Berkley. Some pistol butted trees observed.

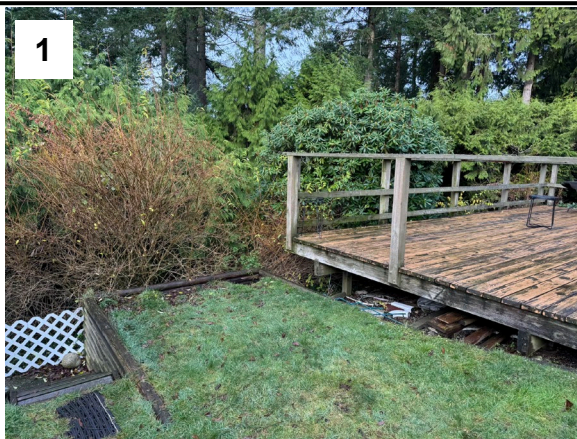
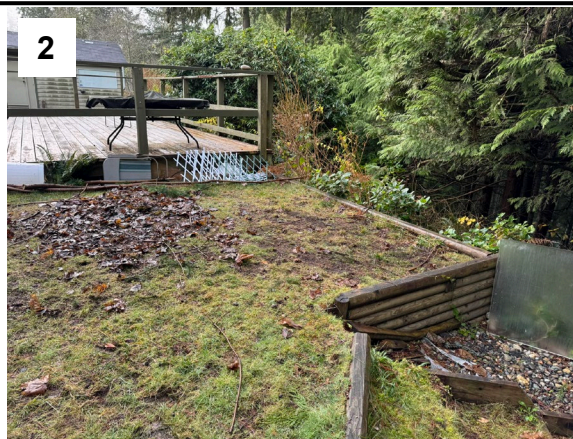
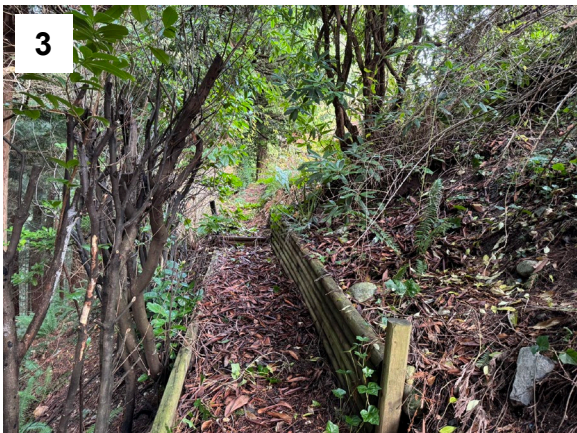
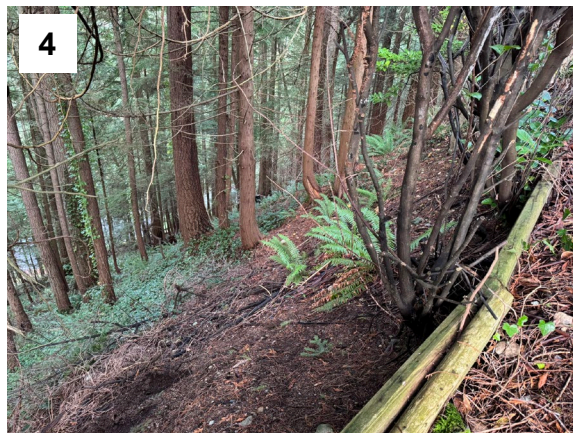
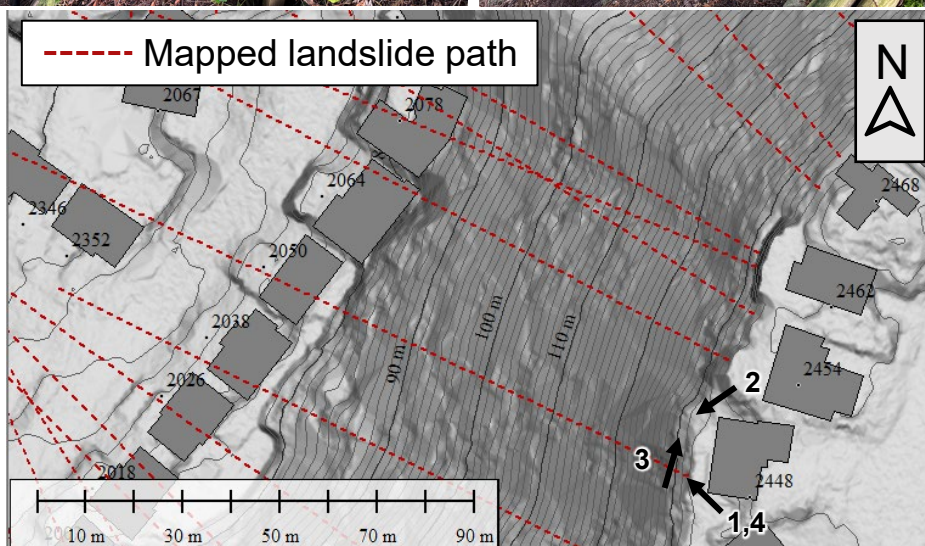
C-7

- Hot tub previously reported no longer there.
- Tiered timber crib retaining walls holding back garden beds in relatively good condition at time of inspection (Photo 3).
- Some pistol butted cedars observed on slope (Photo 4).

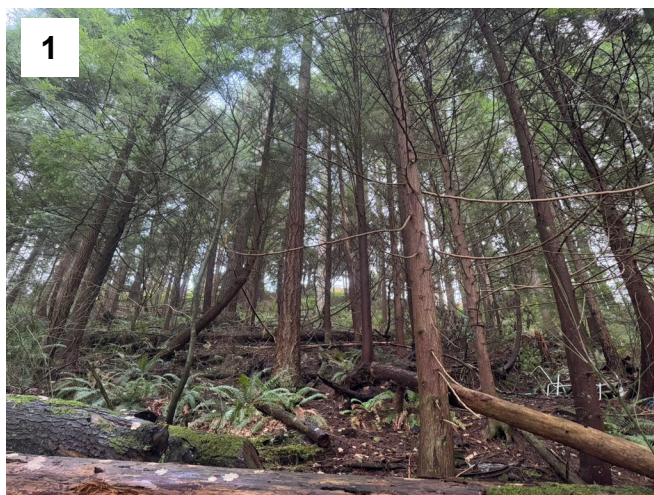
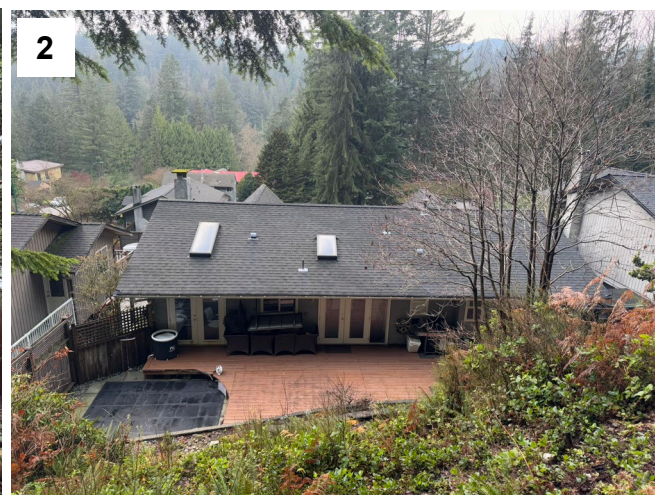
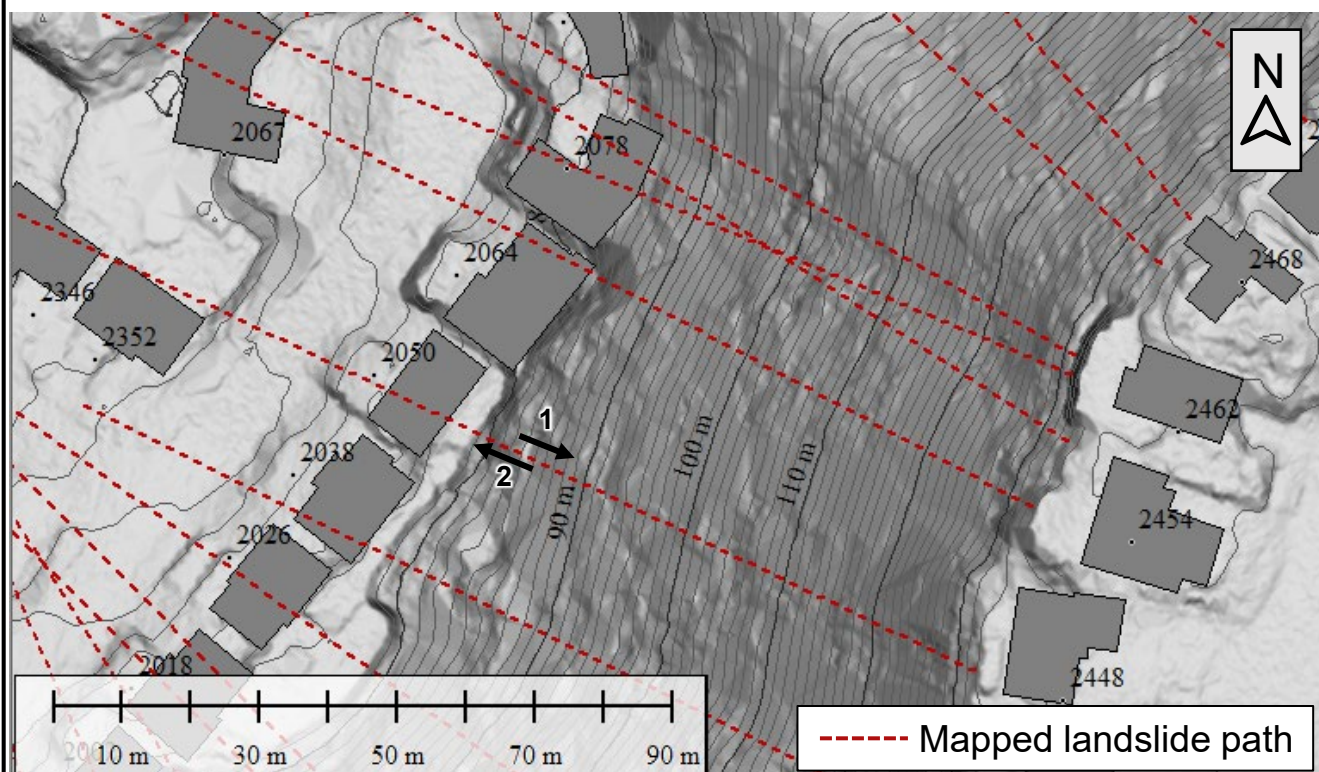
C-8

- BGC traversed slope above 2050 Rivergrove but did not enter backyard to observe condition of retaining wall.

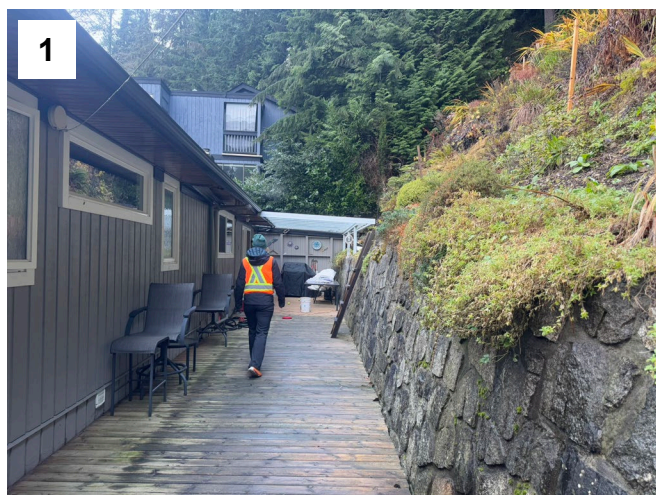
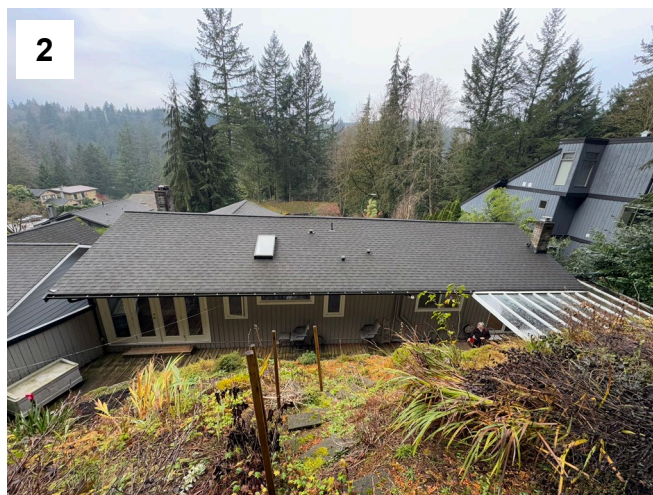
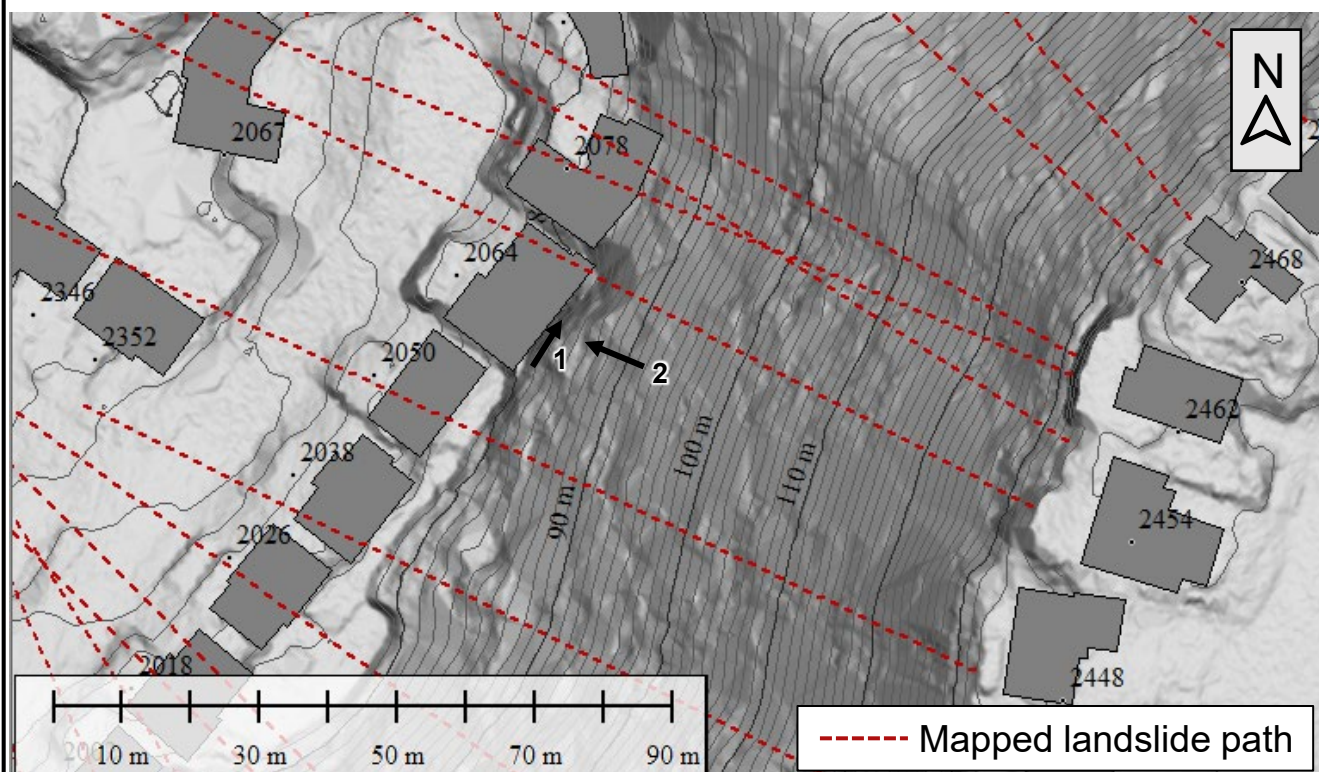
C-9

- Stone retaining wall in good condition (Photo 1).
- House very close to base of slope.

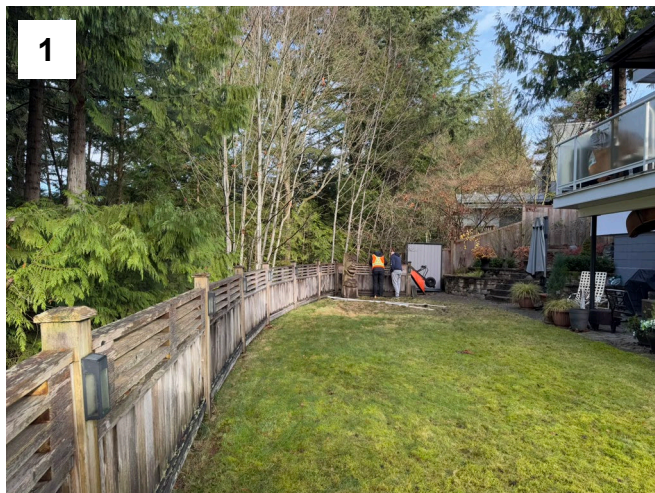
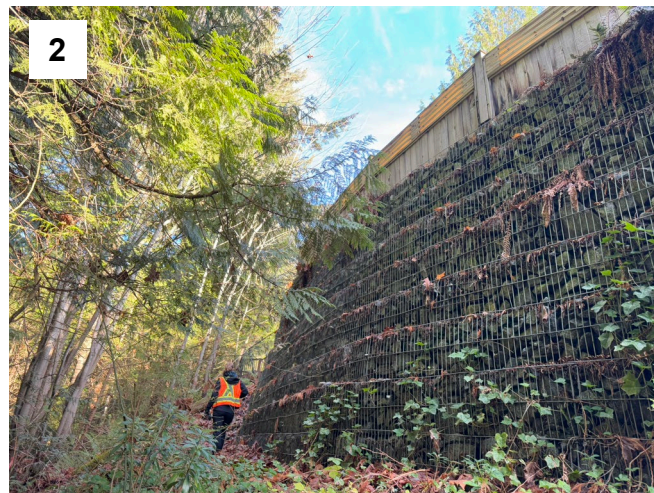
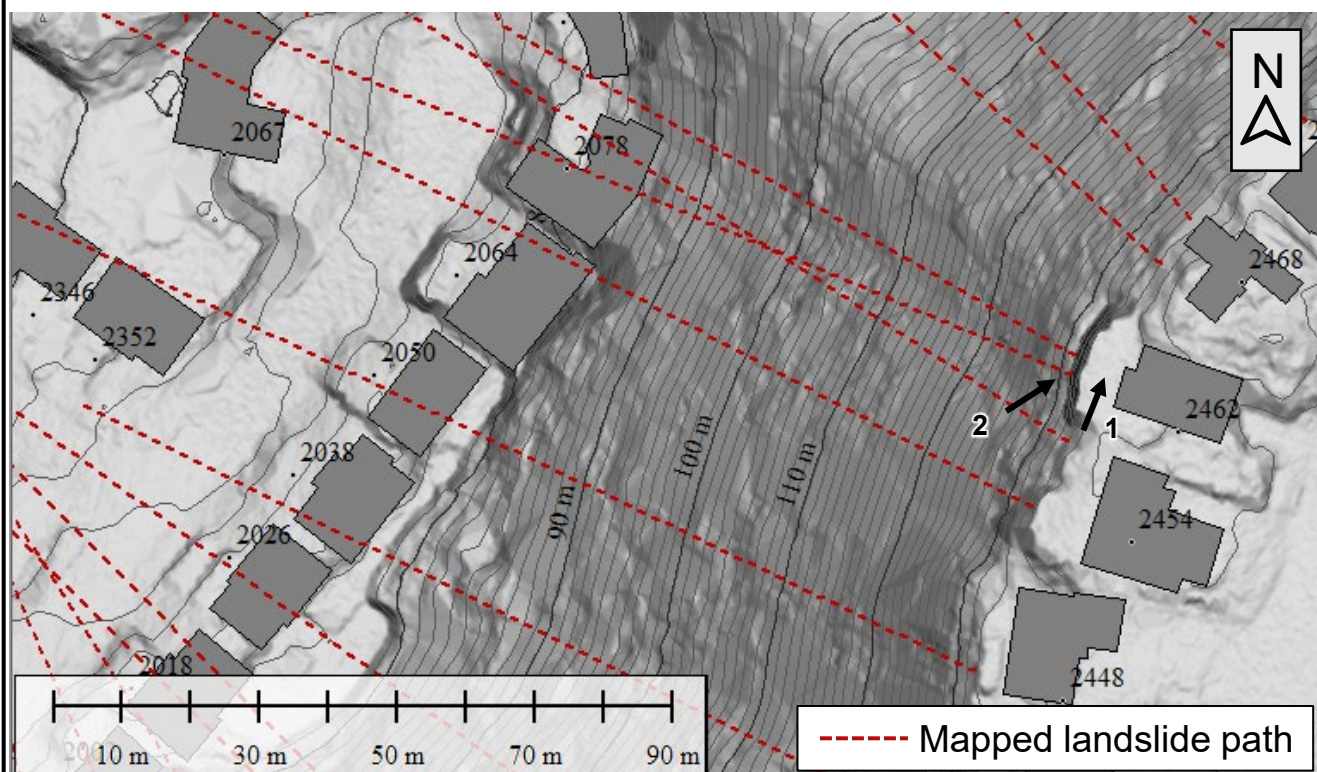
C-10

- Backyard supported with retaining wall (Photo 1). Fence at west side of backyard is tilted. Property owner acknowledged that the fence has never been straight.
- Approximately 4 m tall stepped gabion basket retaining wall with 0.5 m tall gabions (Photo 2). Property owner mentioned the gabion baskets were tied back with geogrid. Retaining wall appeared to be in good condition with no observed bulging or settling at the time of inspection.

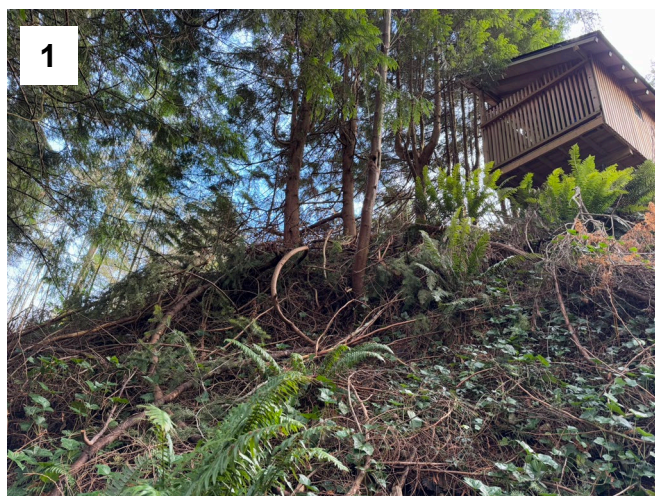
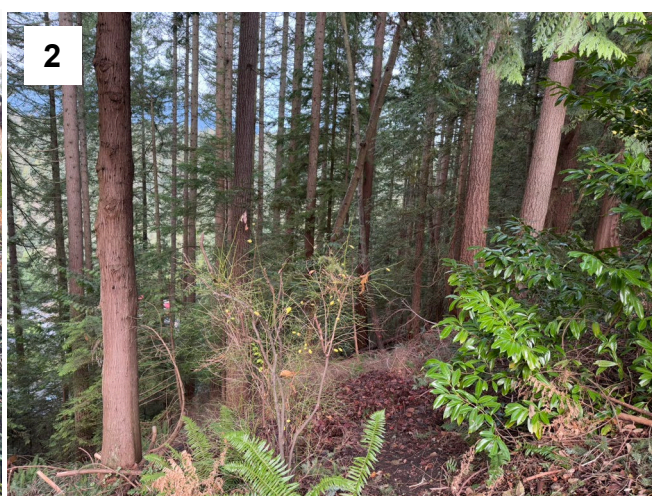
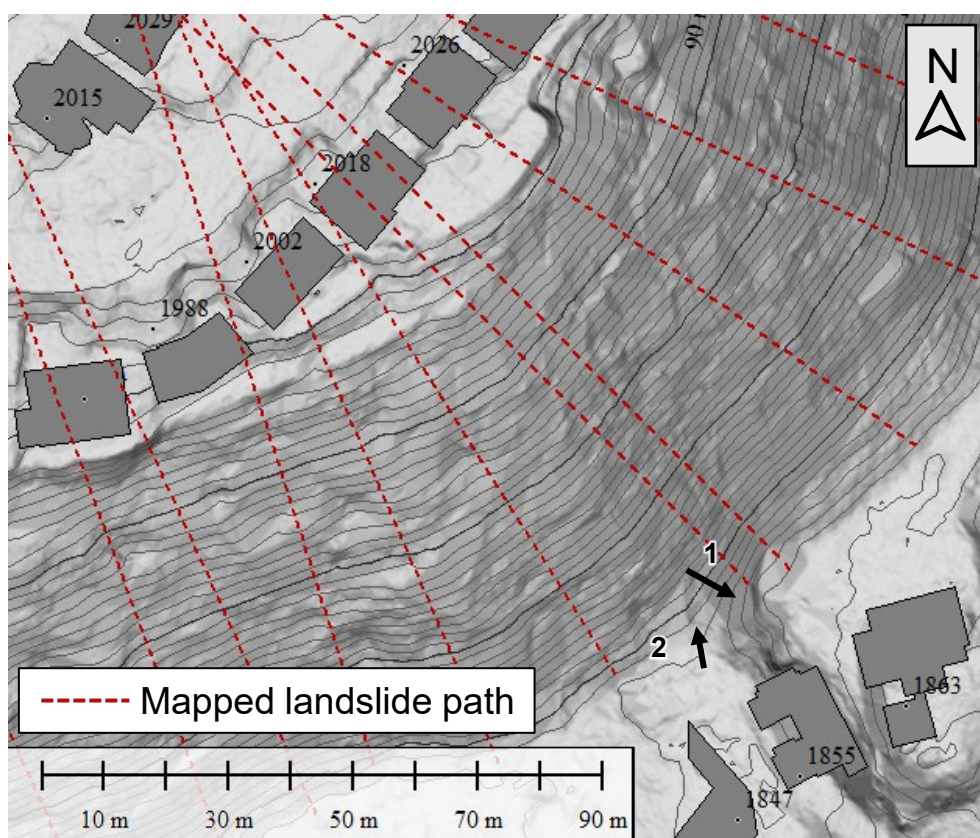
- Yard waste and cuttings observed over slope crest.
- No retaining wall. Relatively gentle slope at crest.

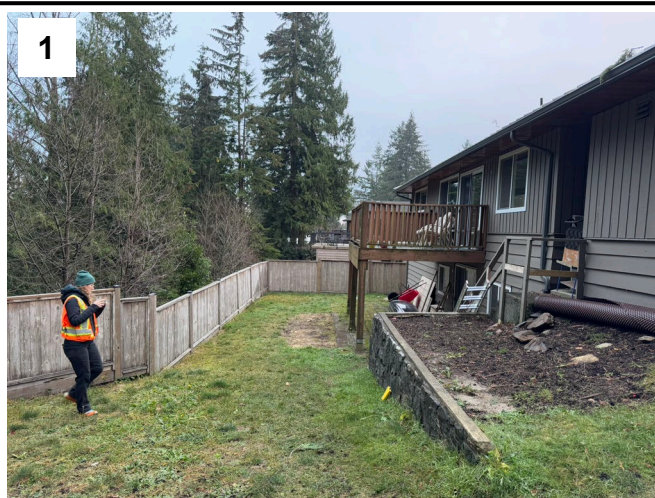
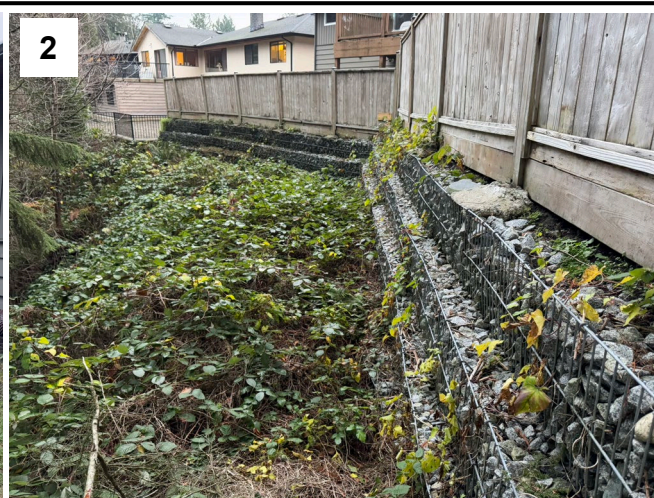
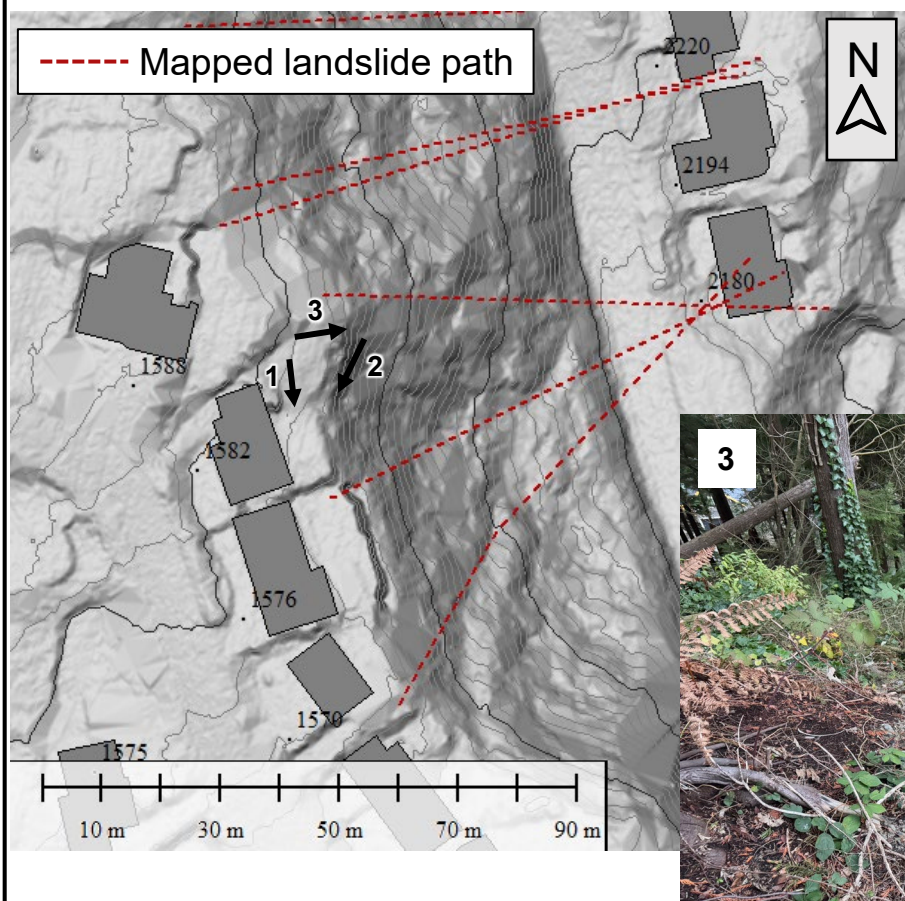
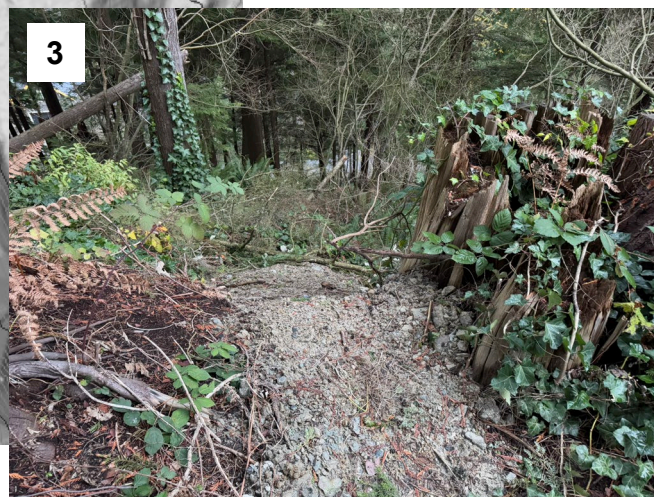
C-13

- Gabion basket retaining wall appears to be in good condition (Photo 2)
- Approximately  $<0.5 \text{ m}^3$  of saturated material (silt and gravel, some clay) placed over the crest of slope at north end of property (Photo 3).

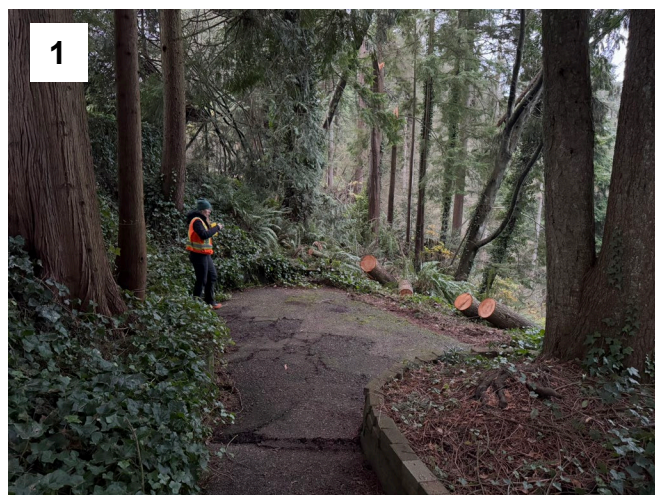
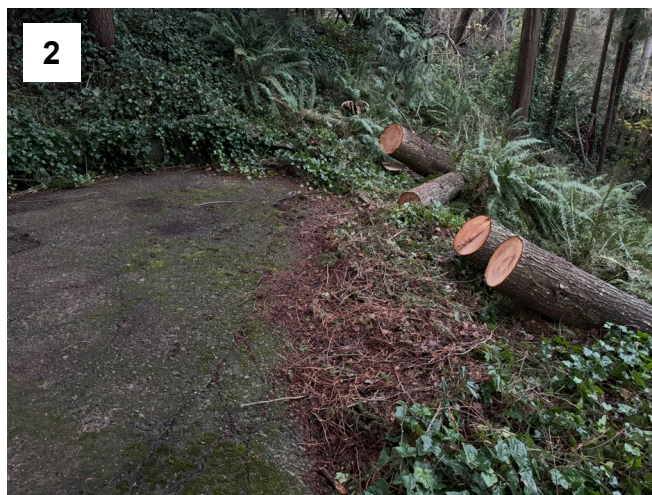
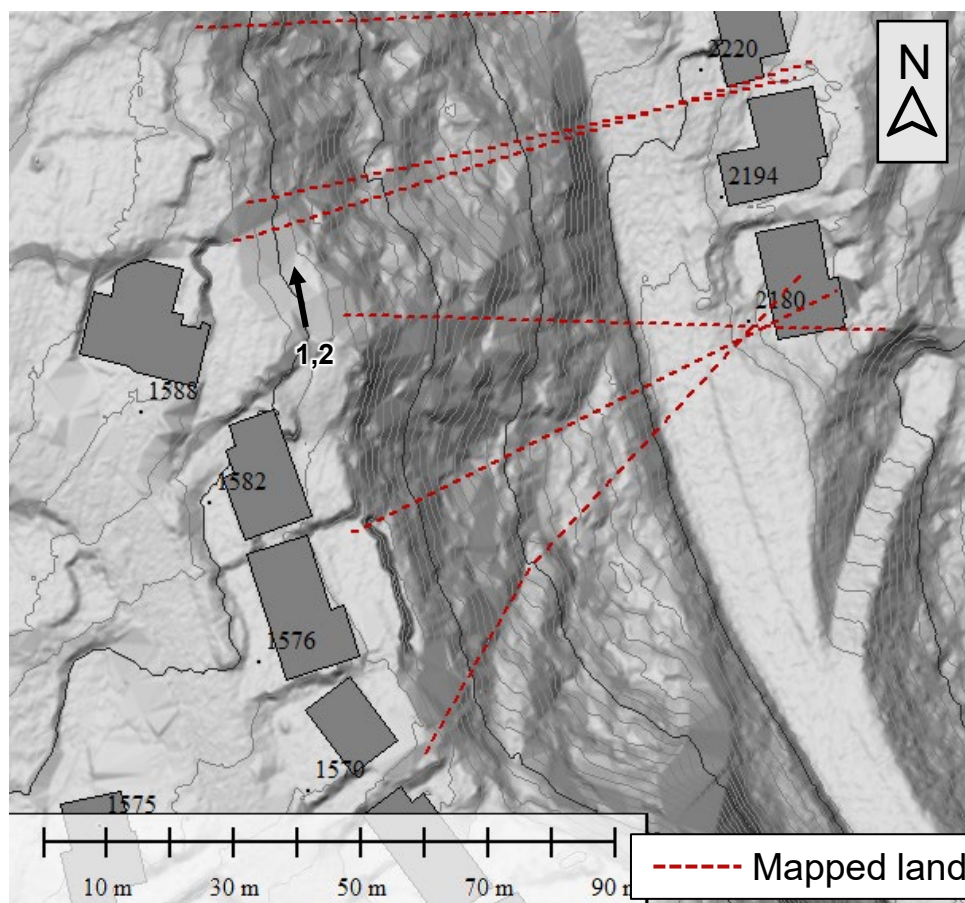
C-14

- Concrete seating area downslope of backyard, sloping outward (Photo 1). Cracks observed in concrete. No retaining wall observed.
- Trees and yard cuttings observed deposited over edge of slope (Photos 1, 2).
