# 2023 ANNUAL DRINKING WATER QUALITY REPORT

*May 2024.*

*District of North Vancouver Utilities Department*

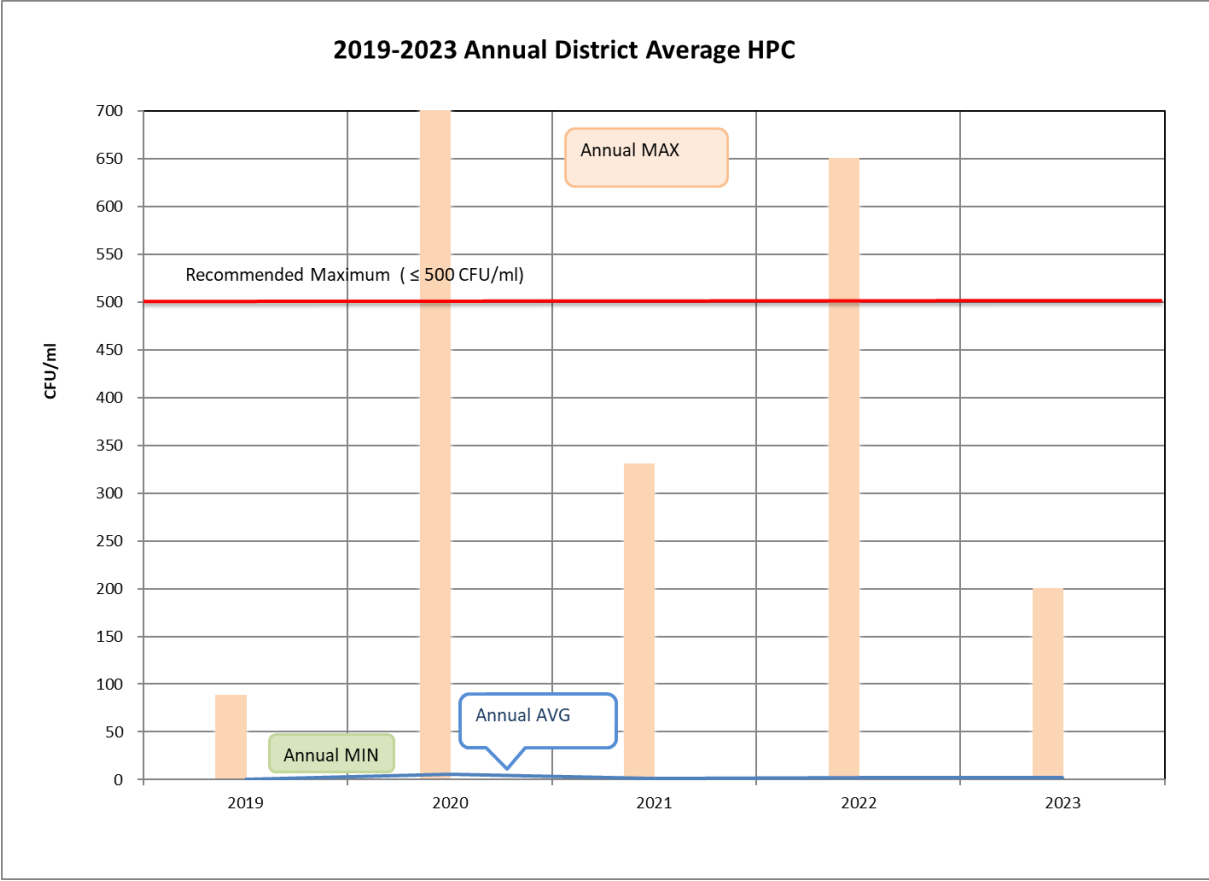
Figure 2. HPC Five Year Annual Average and Maximum Values.

- **HPC:** Heterotrophic plate count is used to monitor general bacteriological quality. The Guideline does not provide an allowable level but instead offers the OG that increases in HPC concentrations above a baseline level of 500 CFU/mL are undesirable.

The scheduled samples collected in 2023 met the guidelines for safe potable water. There were no occurrences of detectable E. coli nor Total Coliform. Four samples were collected in 2023 with turbidity over 1.0 NTU all of which were the result of known operational events in the water system. For these events our response plans outlined in Section 5.7 were followed - operators checked for turbidity and free chlorine immediately upon receipt of the sample (next day at the latest) and levels had returned to normal. Turbidity levels are stable over time. The annual DNV average HPC and turbidity for the last five years are presented below.
