APPENDIX A

ENVIRONMENTAL REVIEW

**RE: DISTRICT OF NORTH VANCOUVER
INTER RIVER PARK SOUTH
ENVIRONMENTAL REVIEW**

Envirowest Consultants Inc. (Envirowest) was retained to complete an environmental assessment of Inter River Park South, North Vancouver, British Columbia (the Property). The District of North Vancouver (District) has proposed the conversion of the existing playing field (Field No. 1) and the construction of a second field (Field No. 2) to increase usage of the south portion of the park.

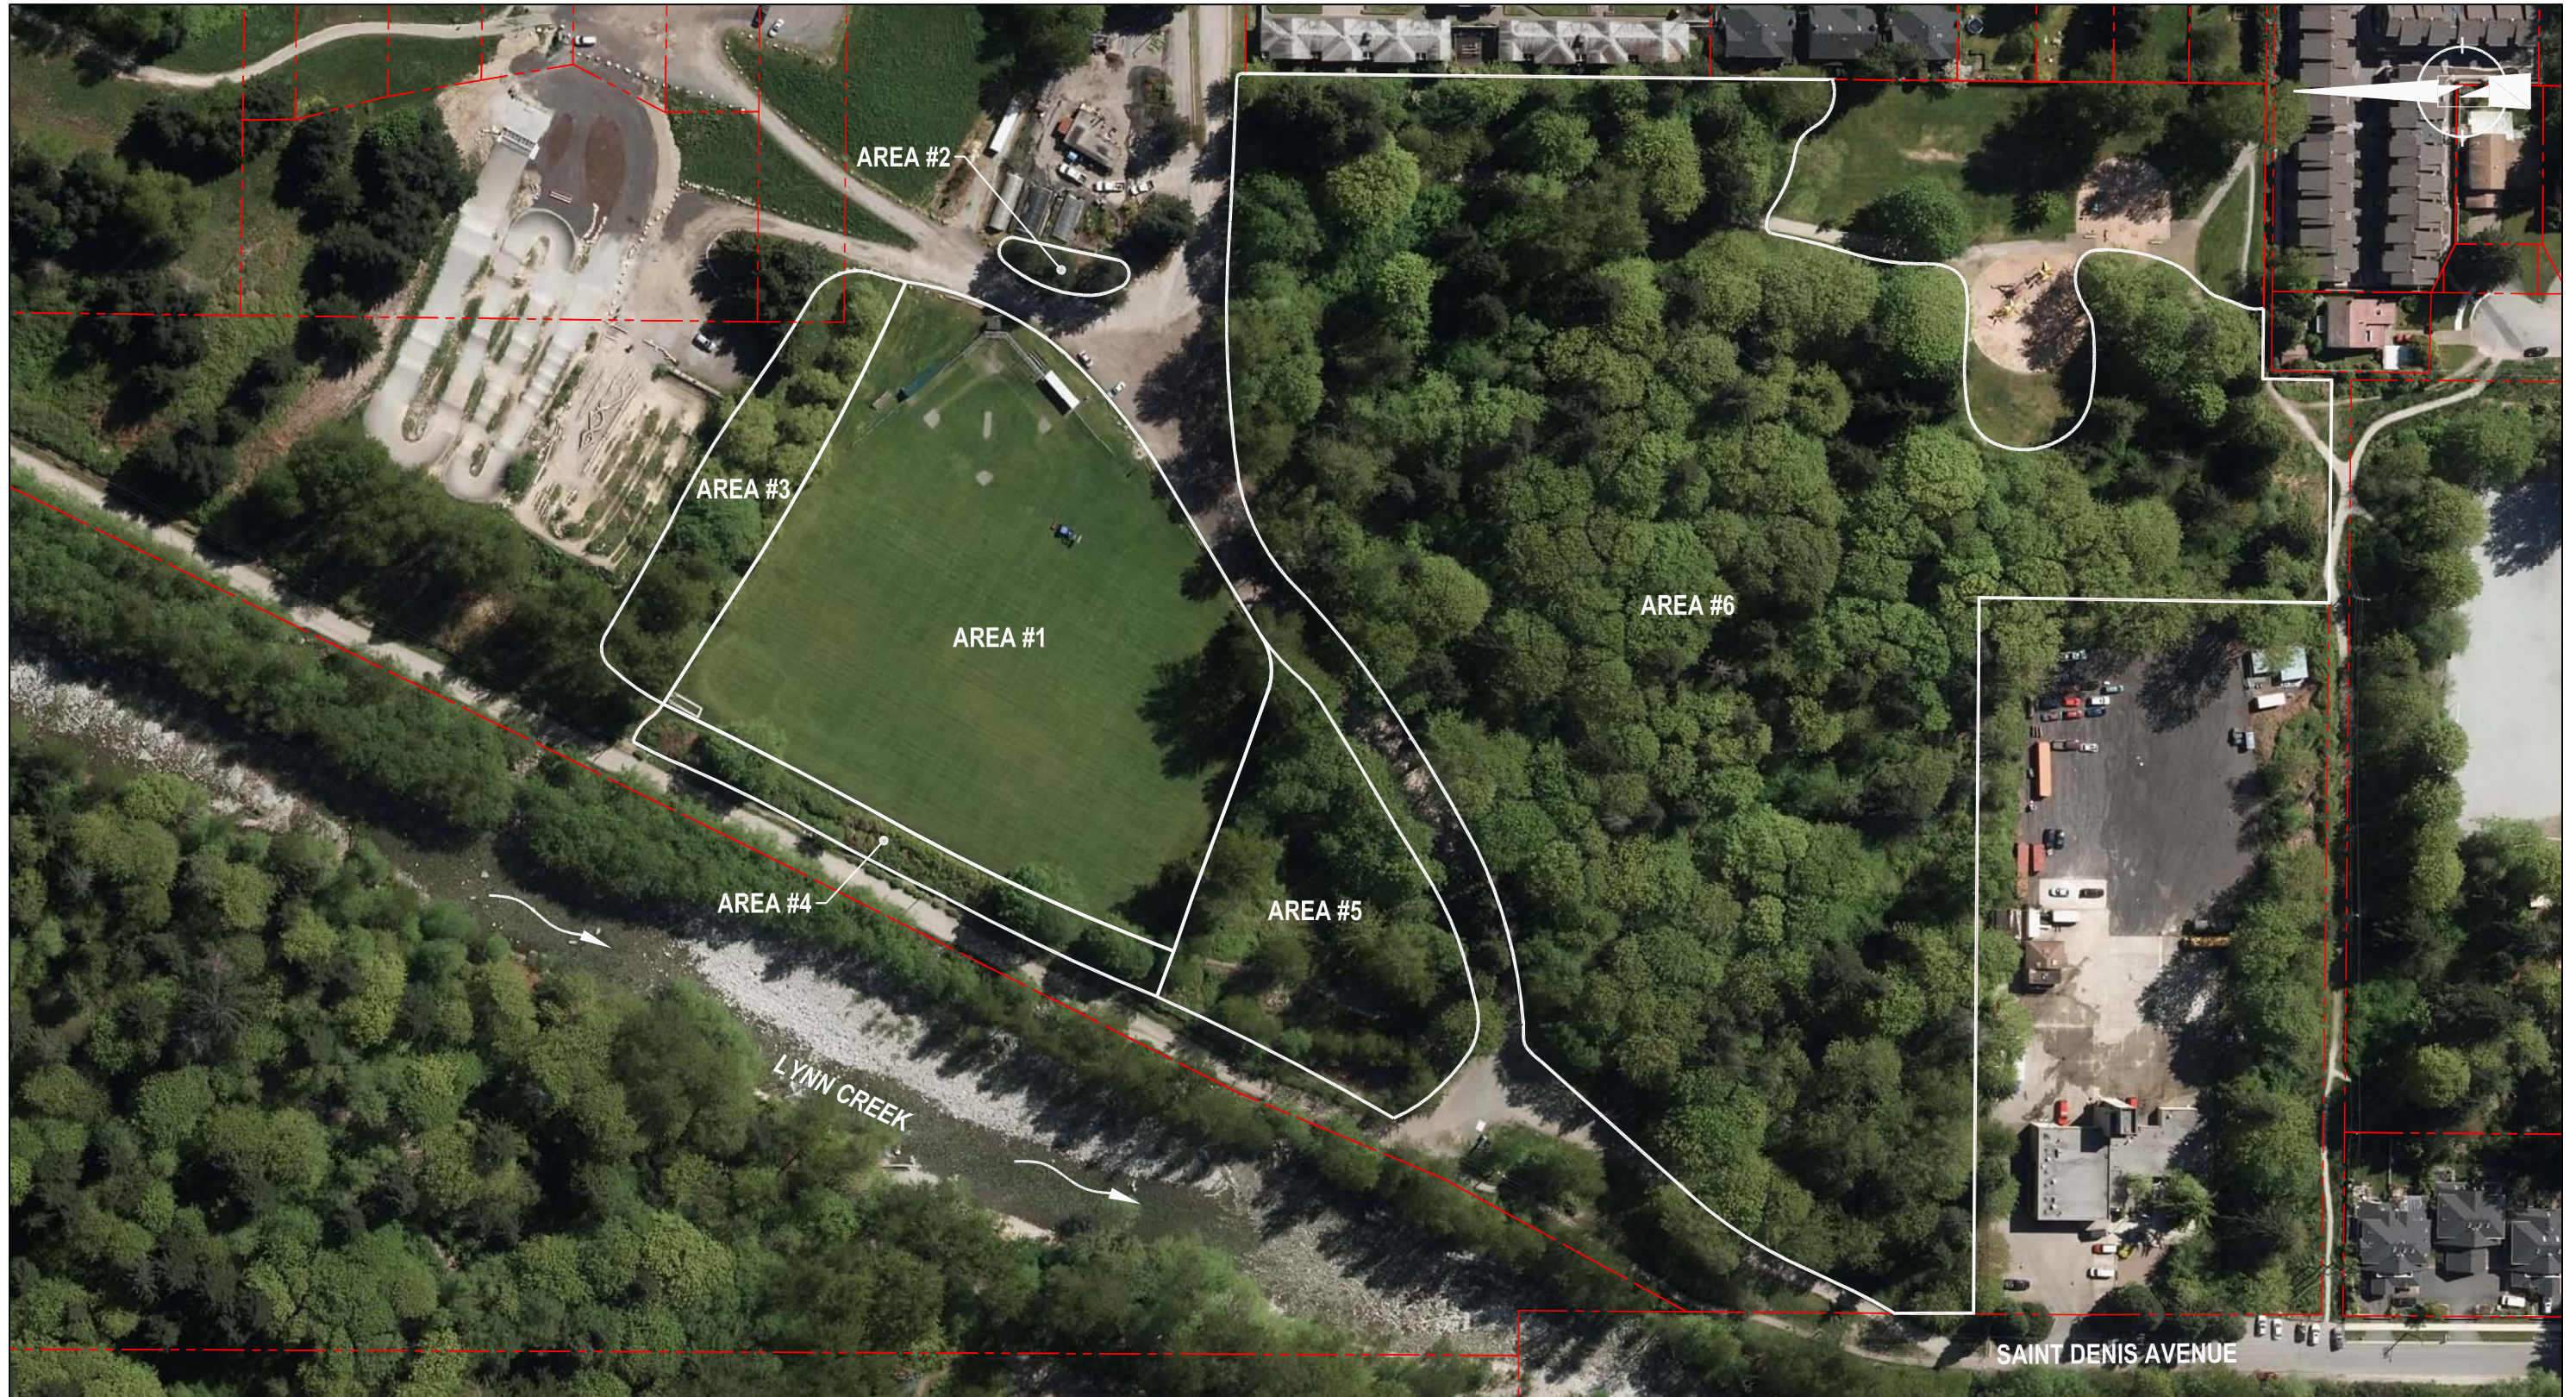
DESIGN: HS/TA	DRAWN: SDJ/CEV	CHECKED: IWW	REVISION: 01	REVISION DATE: April 13, 2017
SCALE: 1:1,500	DRAWING NUMBER: FIGURE 2			
DATE: October 31, 2016

The project location is depicted by Figure 1 in Attachment A. The areas of assessment at the Proposed Work Area are depicted by Figure 2 in Attachment A. Representative site photographs are included in Attachment B.

The Property was divided into six (6) areas of similar vegetation for this assessment. Trees were identified and assessed in terms of ecological function. Tree health/condition, and their viability to be retained adjacent to potential development was assessed independently by BC Plant Health Care Inc. (see arborist report for further details). The six areas are described as:

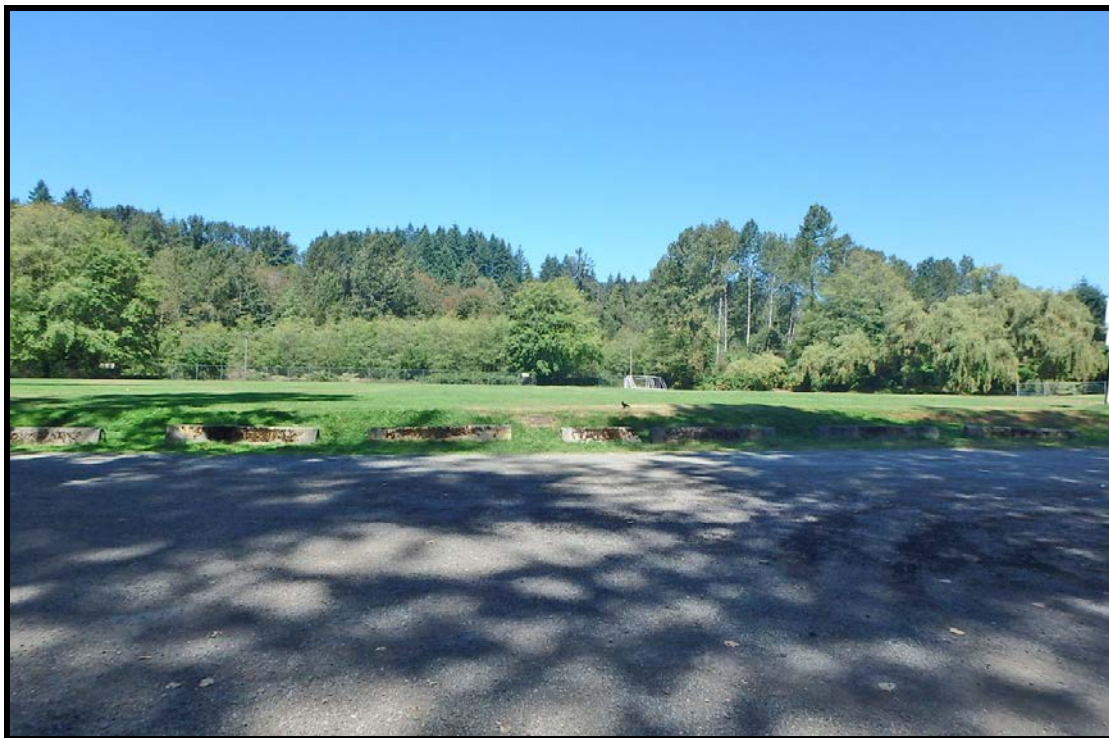
The existing playing field (Field No.1) was comprised of manicured grass. This area is maintained for use as a baseball diamond and soccer field.

Photograph B1. Field #1 (Area 1) looking west from the park service road and parking area (August 16, 2016).

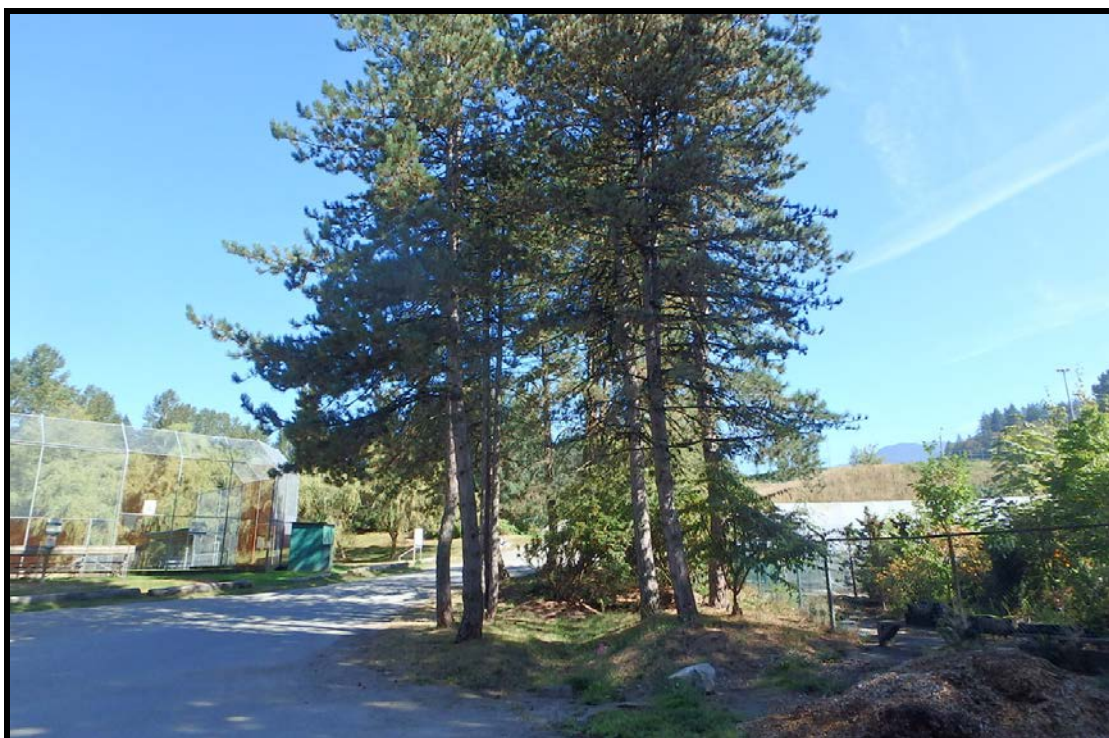
Vegetation in this small area was likely planted and appears to receive regular maintenance. The canopy was comprised of ten (10) lodgepole pine trees (*Pinus contorta* var. *latifolia*). The shrub layer was comprised of two (2) rhododendrons (*Rhododendron* sp.), approximately twelve (12) leatherleaf viburnum (*Viburnum rhytidophyllum*) and Himalayan blackberry (*Rubus armeniacus*). Ground cover was comprised of grasses, red clover (*Trifolium pratense*), ornamental vetch (*Lathyrus* sp.) and common dandelion (*Taraxacum officinale*).

Photograph B2. Planted area west of the nursery (Area 2) looking north (August 16, 2016).

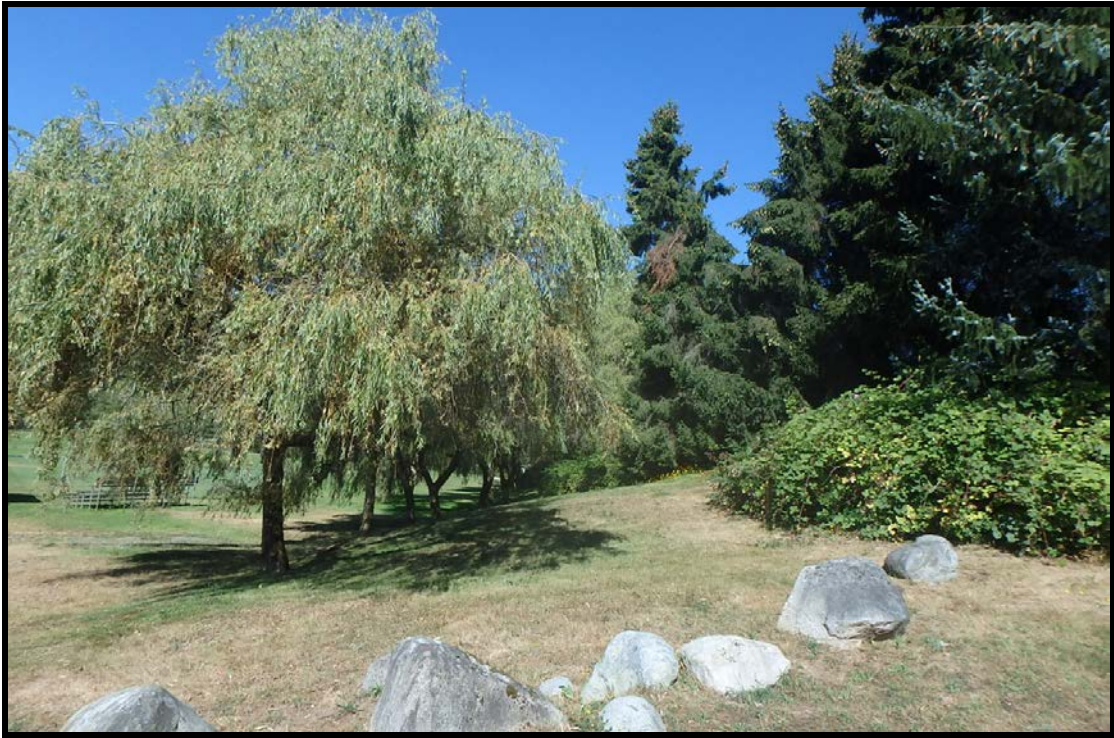
The canopy of Area 3 was characterized by Norway spruce (*Picea abies*) with black cottonwood (*Populus balsamifera* ssp. *trichocarpa*) at the west end. There was one (1) Sitka spruce (*Picea sitchensis*) at the east end adjacent to the access road. The shrub layer was a thick Himalayan blackberry thicket with sporadic mountain ash (*Sorbus sitchensis*). Ornamental vetch and English ivy (*Hedera helix*) occurred throughout the area. To the south a row of willow (*Salix* sp.) was separated from the main stand by manicured grass.

Photograph B3. Area north of Field #1 (Area 3) looking west (August 16, 2016).

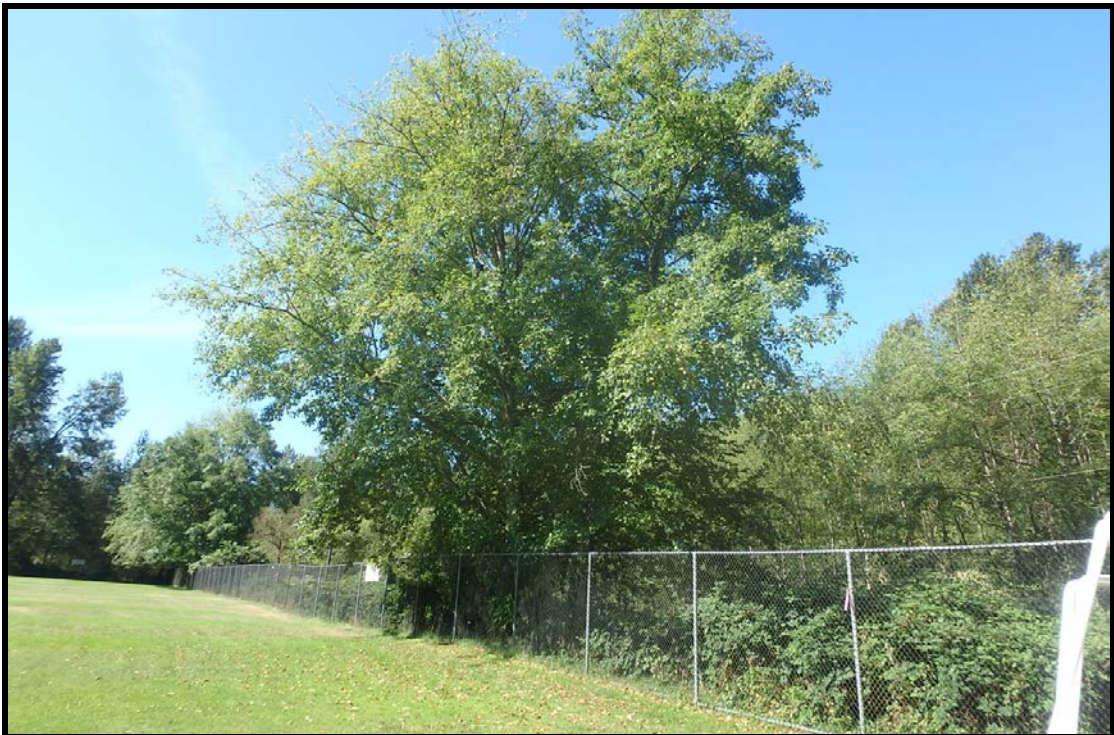
The area west of Field No.1 and east of the trail along Lynn Creek occurs within an existing 30 metre riparian setback from Lynn Creek. This area has been highly disturbed and as a result the vegetation was largely invasive species. The canopy of Area 4 was characterized by red alder (*Alnus rubra*) with pole sapling black cottonwood. The shrub layer was characterized by

Photograph B4. Disturbed area within riparian setback west of Field #1 (Area 4) looking west (August 16, 2016).

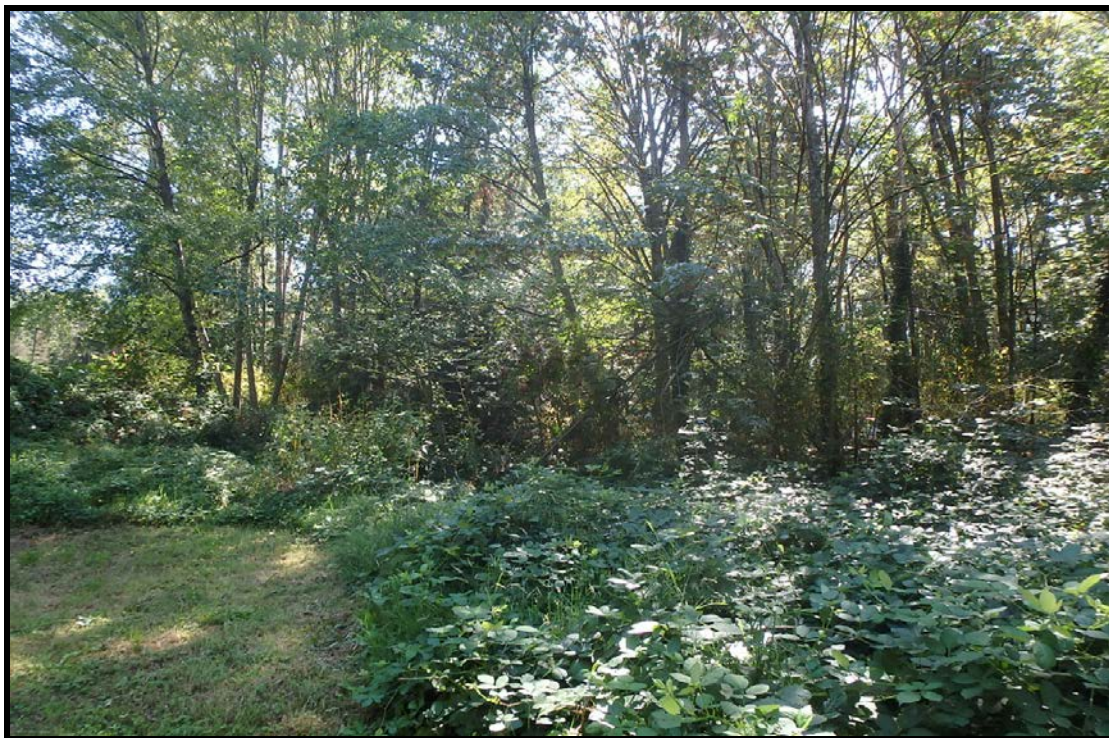
The canopy of the lower treed area was characterized by bigleaf maple (*Acer macrophyllum*), red alder, black cottonwood and western redcedar (*Thuja plicata*). Snags were also present within Area 5. The shrub layer was characterized by Himalayan blackberry, vine maple (*Acer circinatum*), snowberry (*Symphoricarpos albus*) and policeman's helmet (*Impatiens glandulifera*). Indian plum (*Oemleria cerasiformis*) observed were in poor health. Ground cover was characterized by ornamental vetch, horsetails (*Equisetum arvense*), herb-Robert and sword fern (*Polystichum munitum*). Bird's-foot trefoil and morning glory were also present throughout the area. Leaf litter was shallow and interspersed with patches of exposed ground.

Photograph B5. Lower treed area south of Field #1 (Area 5) looking east (August 16, 2016).

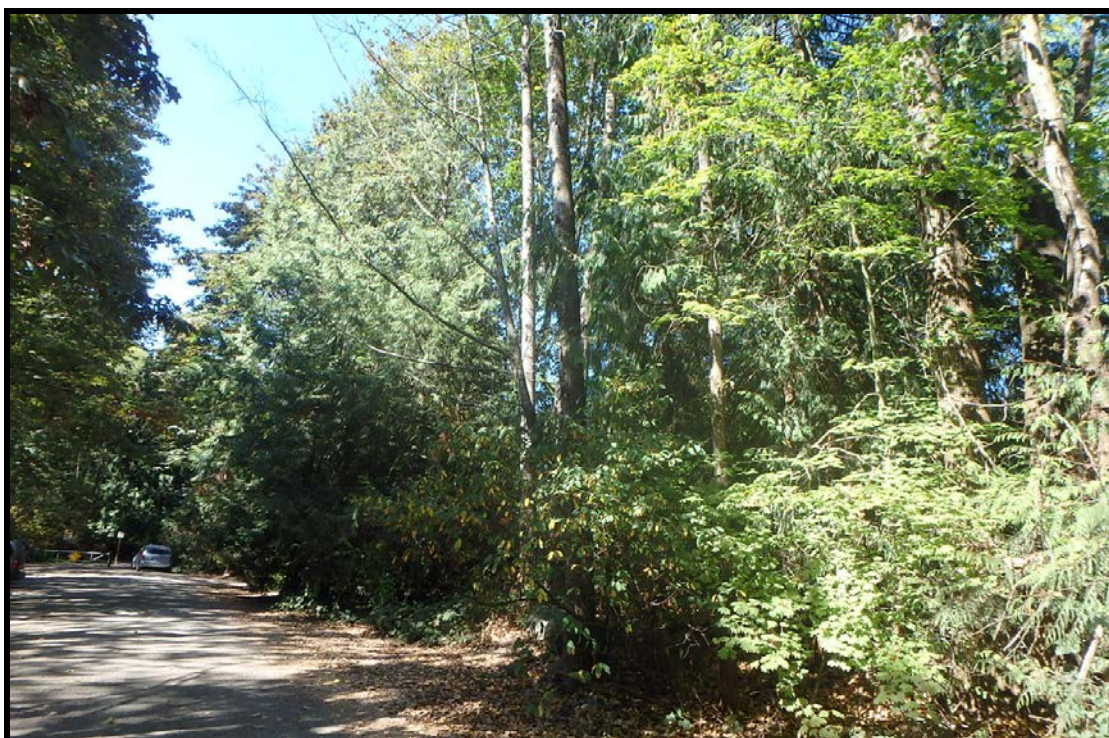
Photograph B6. Lower treed area south of Field #1 (Area 5) looking northwest from the park service road (August 16, 2016).

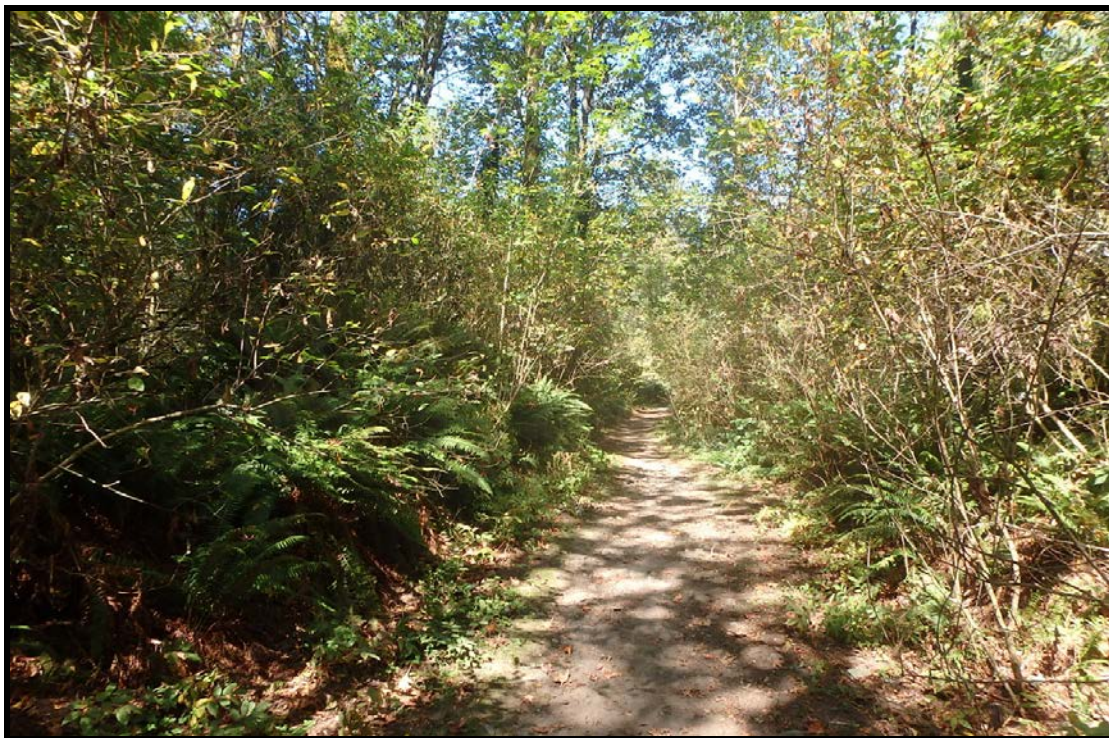
Photograph B7. One of multiple trails within the forested area southeast of the park service road (Area 6) (August 16, 2016).

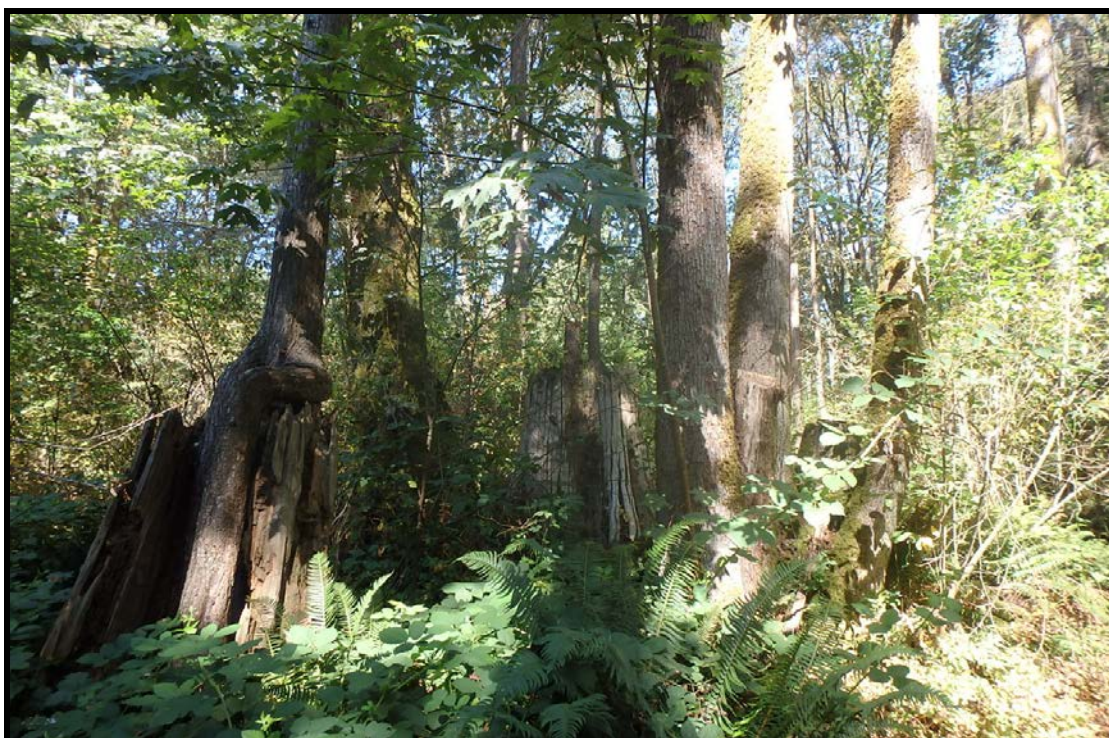
Area 6 consists of second-growth mixed-wood forest that has not yet reached a climax state. As such, the canopy also includes bigleaf maple (*Acer macrophyllum*) with minor amounts of black cottonwood (*Populus trichocarpa*) in addition to western hemlock and western redcedar. The understory is dominated by Indian-plum (*Oemleria cerasiformis*), salmonberry (*Rubus spectabilis*), vine maple (*Acer circinatum*), swordfern (*Polystichum munitum*), Himalayan blackberry, Pacific ninebark, red elderberry and common snowberry (*Symphoricarpos albus*). English holly (*Ilex aquifolium*) and Japanese maple (*Acer palmatum*) were also observed in the area. Ground cover was characterized by herb-Robert, false Solomon's seal, policeman's helmet, spiny wood fern (*Dryopteris expansa*), dead nettle (*Lamium galeobdolon*) and English ivy.

Photograph B8. Forested area southeast of the park service road (Area 6) (August 16, 2016).

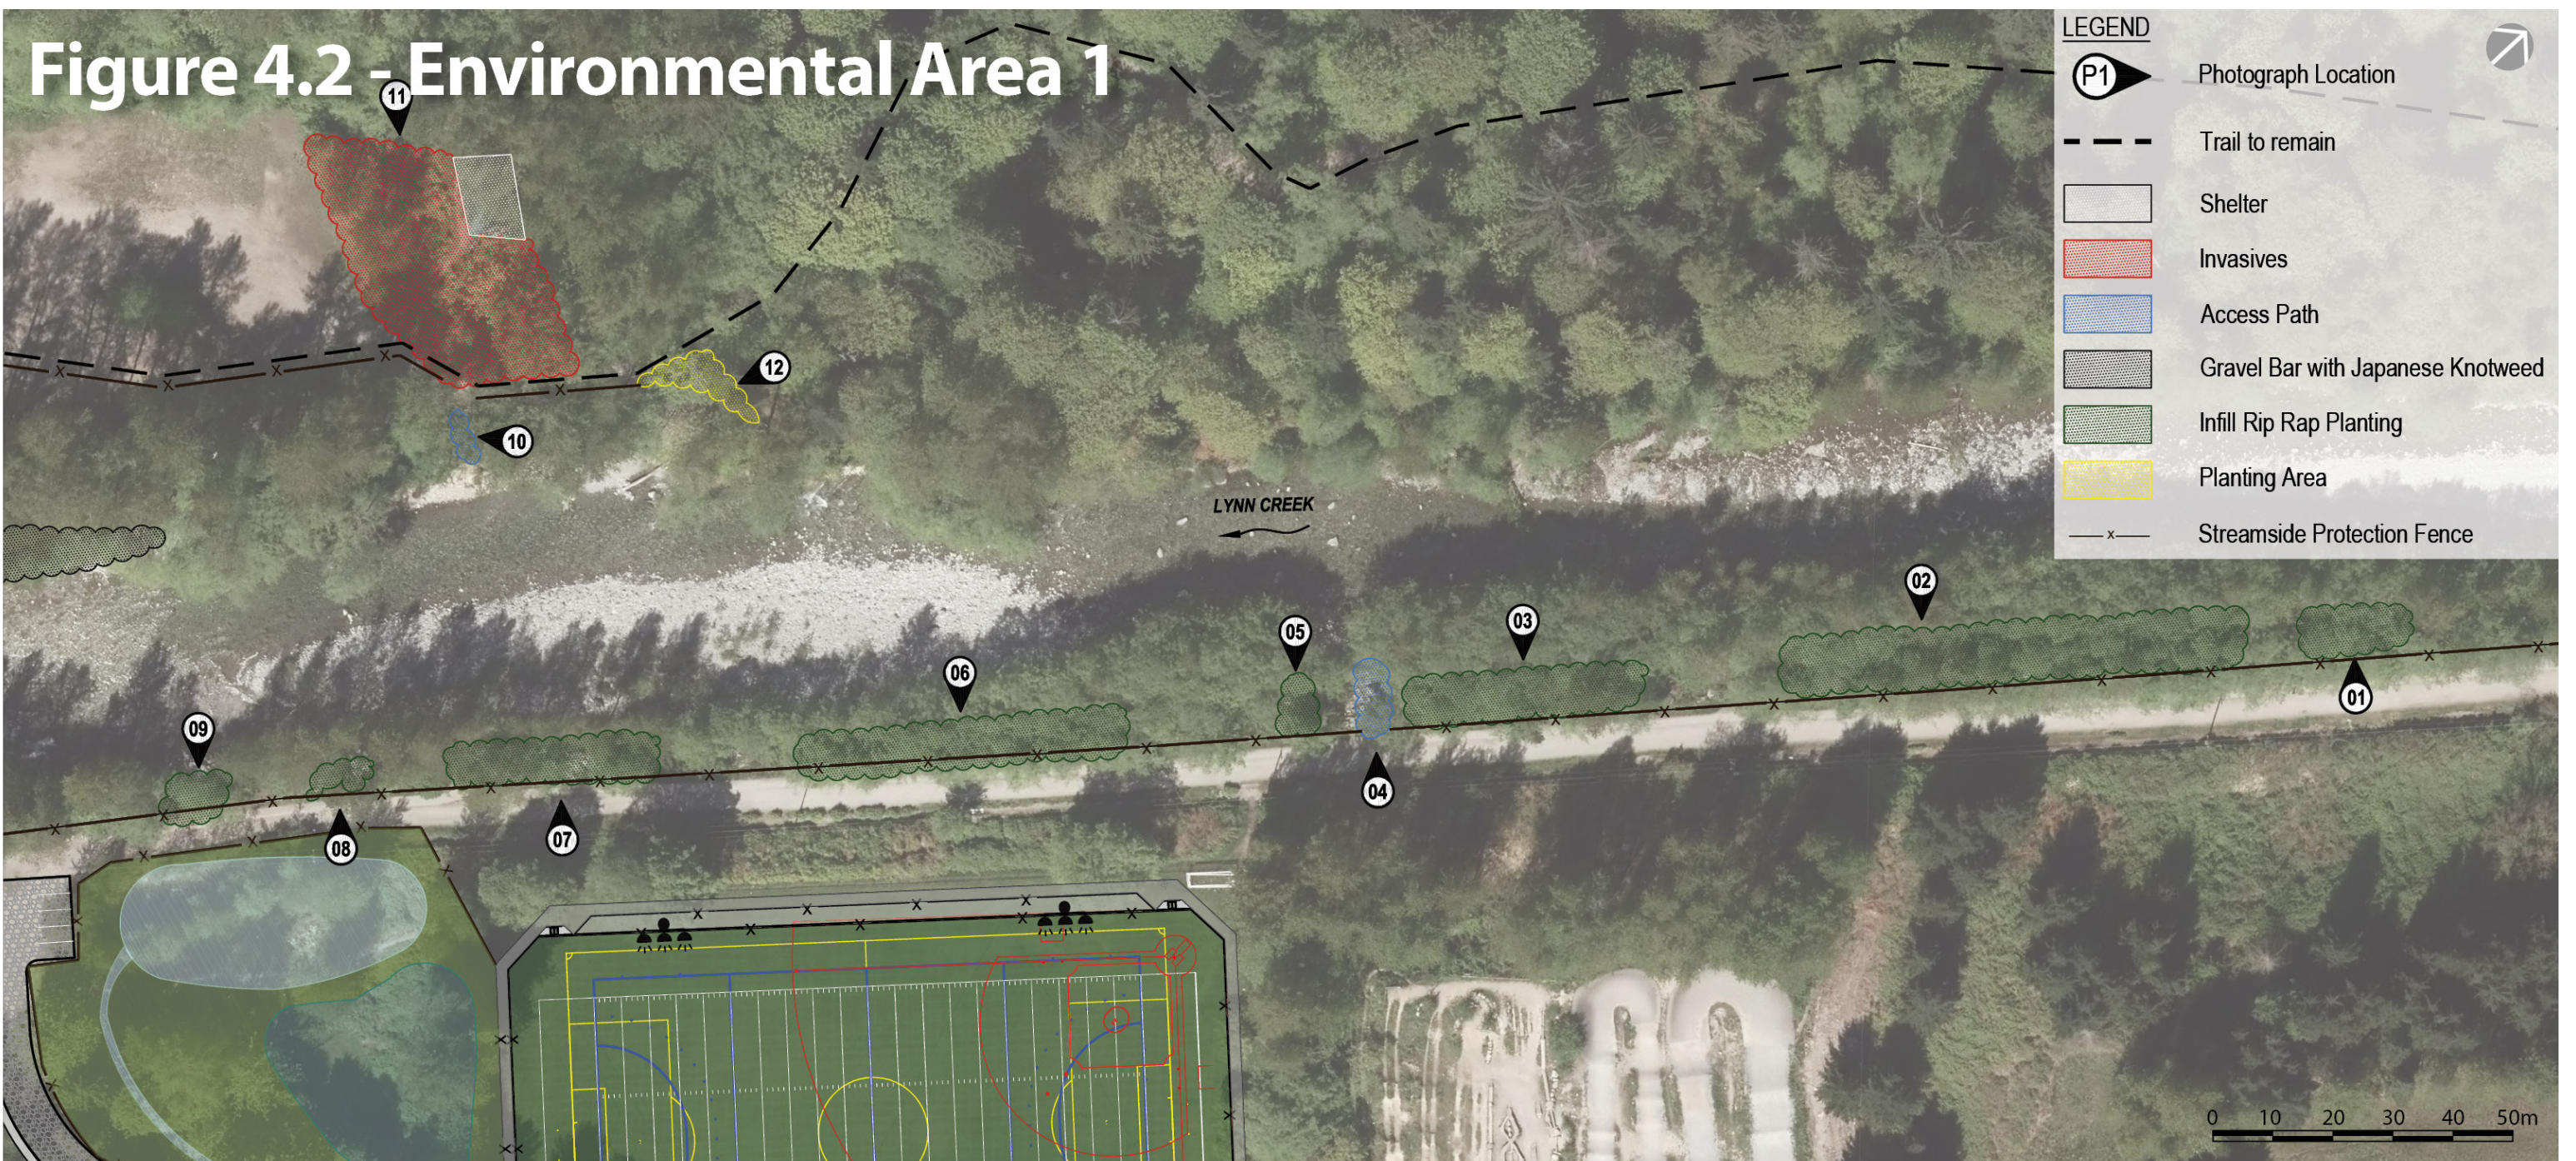
Invasive non-native species observed on the Property include Himalayan blackberry, English ivy, Japanese knotweed, morning glory, English holly, laurel and lamium. These plant species spread aggressively and displace native vegetation to the detriment of native plants, adversely affecting habitat and the wildlife they support. Invasive plants should be removed anywhere they occur on the Property, employing species-specific methodologies. Re-establishment of native plant communities must follow the removal of the invasive species, and utilize plants suited to the site/soil conditions. Species best suited include the native plants identified on the Property, and should generally include trees, shrubs and groundcover species. Long-term (minimum 5 years) monitoring and maintenance is important to prevent re-establishment of the invasive plants, and to ensure establishment of the native plants. Specific areas identified for invasive species removal include the area around the picnic shelter near the large off-leash dog area on the west side of Lynn Creek (Photograph 11 on Figure 4.2), a large gravel bar within the Lynn

There are areas within the Property that are lacking native vegetation (exposed soil or maintained grasses) that can be enhanced by planting assemblages of native tree, shrub and groundcover species. These include areas on the west side of Lynn Creek, just north of Highway 1 (Photograph 19 on Figure 4.3), near the powerline right-of-way (Photograph 21 on Figure 4.3), along the informal trail through the forested area on the western edge of the park (Photograph 22 on Figure 4.3), and in areas along the river bank that have had heavy foot traffic (Photograph 12 on Figure 4.2).

Note: Photos 1-12 reflect current conditions and were taken on May 2, 2017

The eastern creek bank has been reinforced with rip rap and there are several areas with opportunities to conduct infill planting among the rip rap, utilizing engineered “eco-pockets” (Figure 4.2 and Figure 4.3). Tree species used for areas of reforestation will include species typical of the CWHdm forest, and are also found currently on site: western hemlock and western redcedar. These areas will also include planting of shrubs such as salmonberry, salal, vine maple, Indian-plum, sword fern and common snowberry and placement of coarse woody debris. In areas that will require large amounts of invasive removal (such as Area 4), plantings will focus on early seral, fast growing species such as red alder (*Alnus rubra*) and black cottonwood, that will provide a shade canopy as quickly as possible to outcompete the invasives and prevent re-establishment. Mid-shade tolerant species (Douglas-fir and western red cedar) are recommended in forest openings and along edges, and early successional species should be interspersed among those edges. Shade tolerant native species can be planted beneath the early seral, fast growing species, which will result in the fast growing alder and black cottonwood acting as nursery trees. This will result in the more typical late succession longer lived species become established in an ecologically appropriate manner.

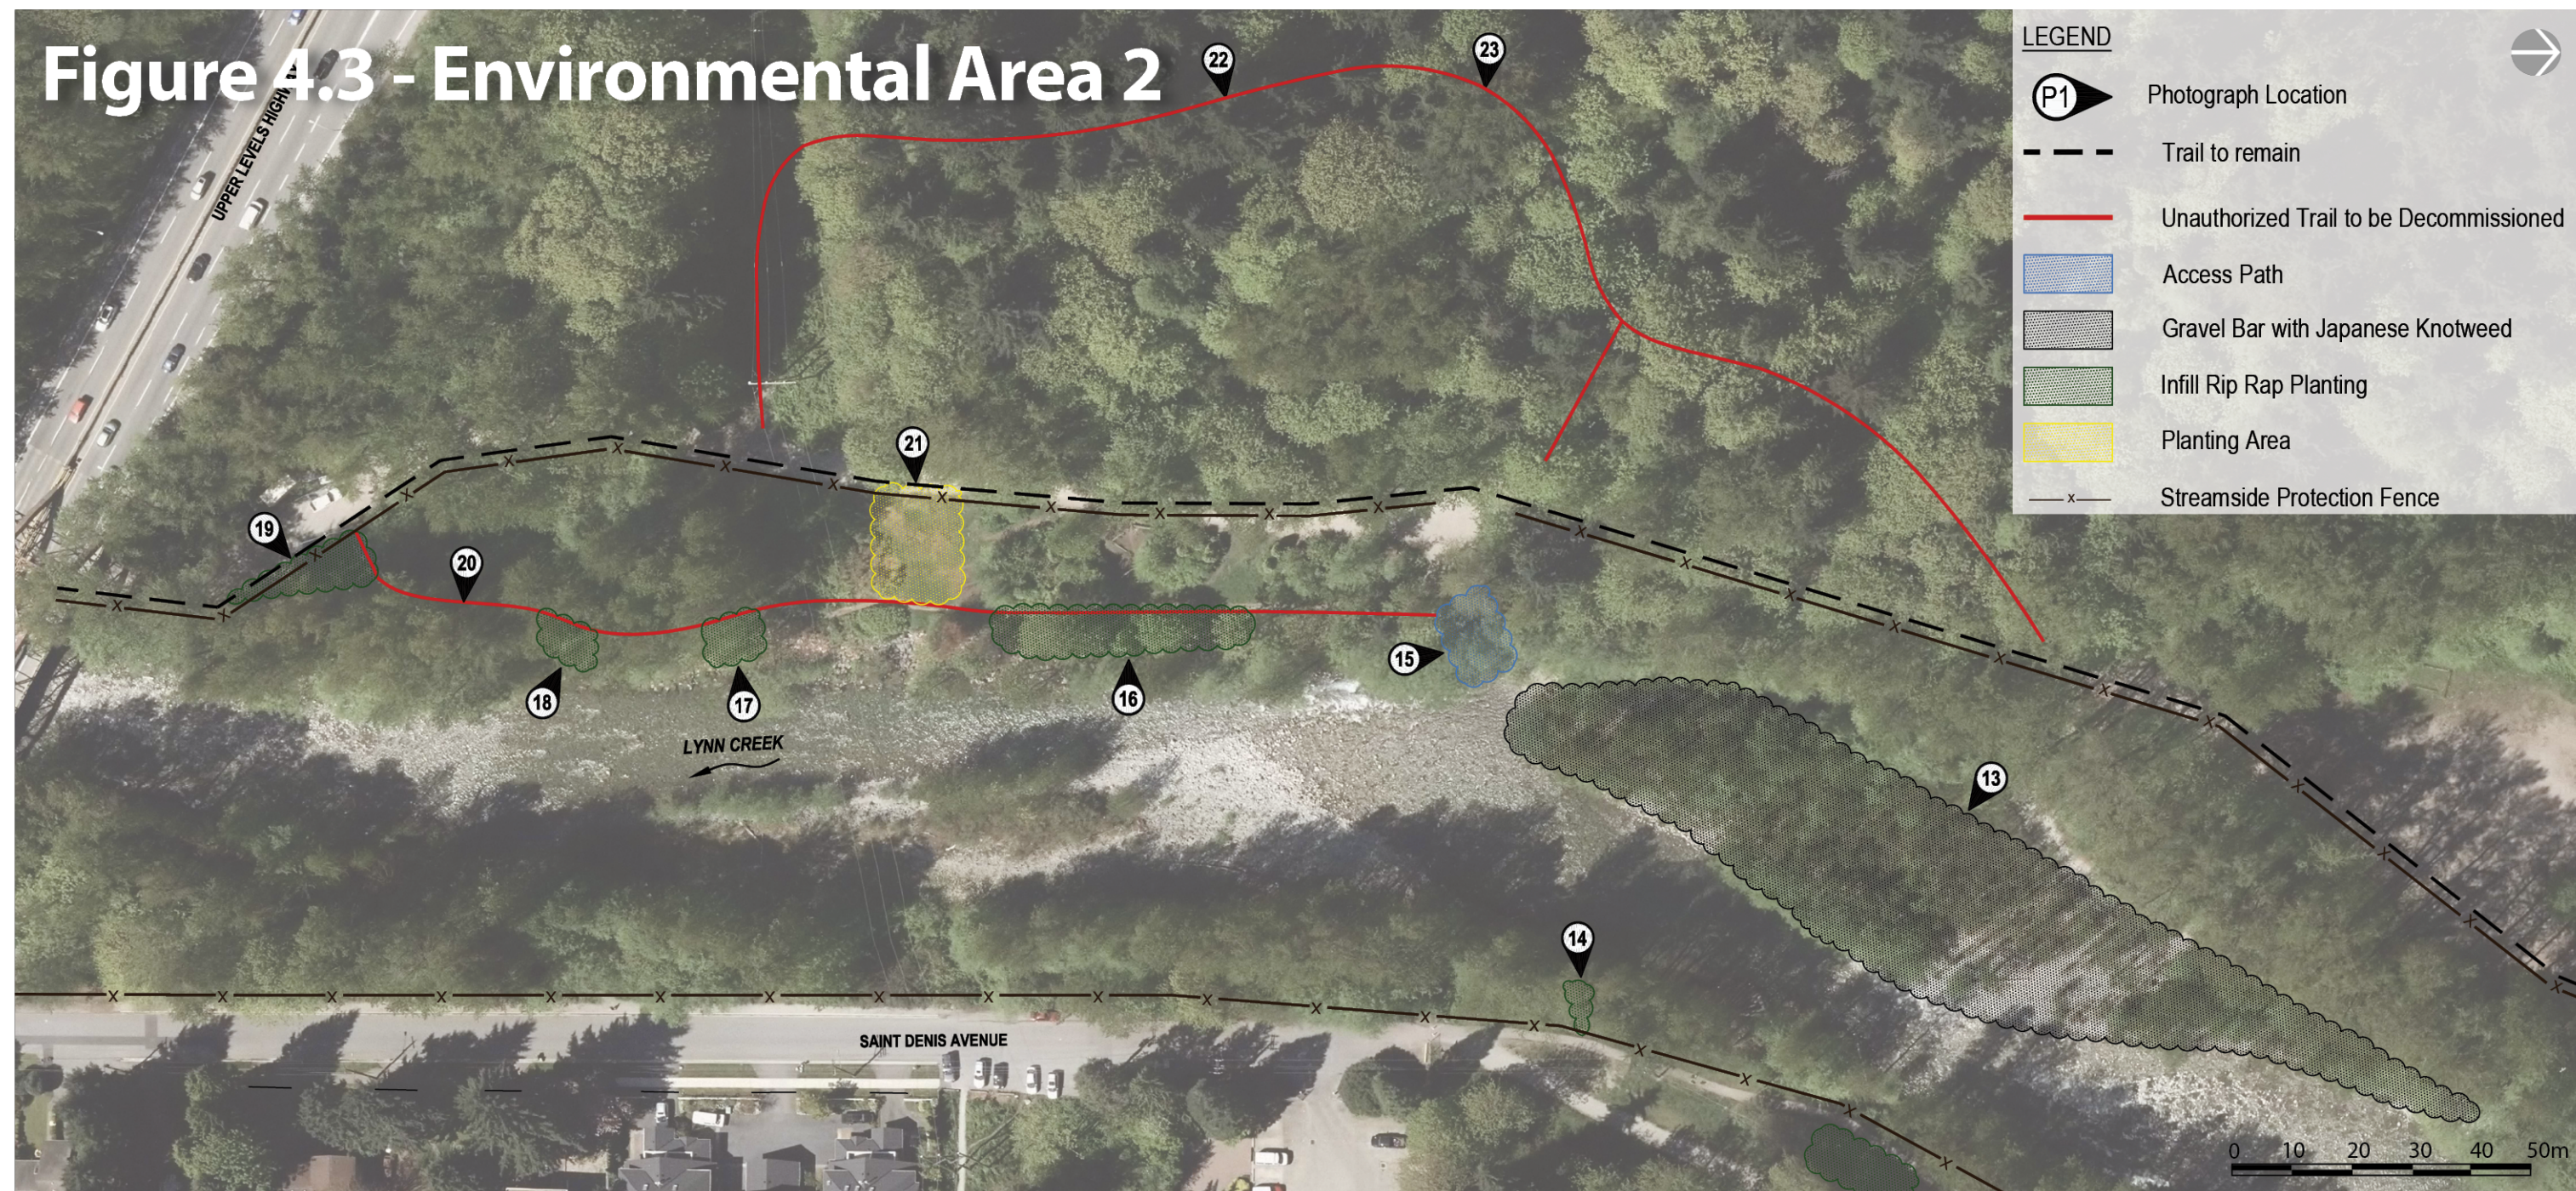
Creek channel that has Japanese knotweed throughout (Photograph 13 on Figure 4.3), and the area just beneath the powerline right-of-way (Photograph 21 on Figure 4.3).

Note: Photos 13-23 reflect current conditions and were taken on May 2, 2017

23) Remove makeshift bridge

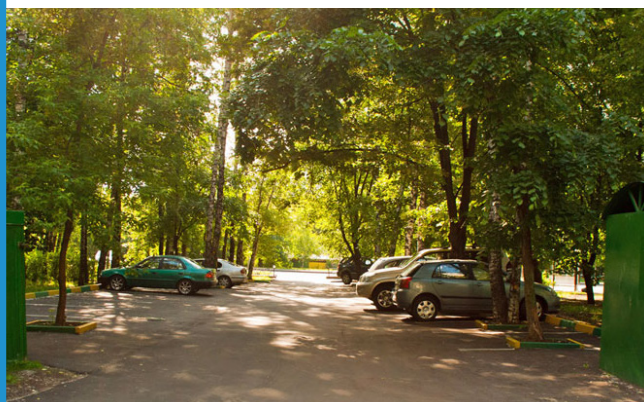
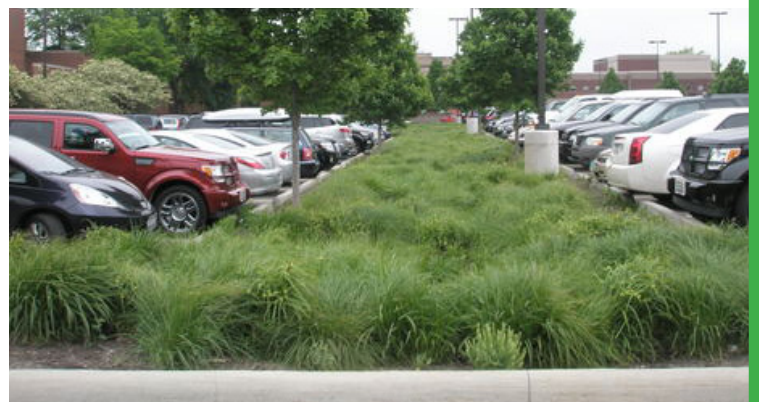
Figure 4.5 - Bio Wetland Examples

Photographs of constructed wetlands are included in Figure 4.5 (Attachment C).

The existing pond at the southwest corner of Area 5 provides the only aquatic habitat (excluding Lynn Creek) within the portion of the Property where works are proposed. The pond has limited functional value for wildlife given its artificial banks (lined with gravel) and fluctuating water level. The expansion and enhancement of this pond is recommended. The pond side slopes should be flattened and landscaped. The bottom of the pond should provide a diversity of depths and landscape treatments with emergent/submergent plants. Boulder clusters and woody debris (e.g. logs) should be placed in and adjacent to the water surface to provide habitat diversity.

In order to support increased habitat value, the water level of the pond should be controlled to a limited fluctuation of no more than 300 mm. Presently, the pond fills completely and overflows as the existing outlet culvert is not presently connected to the creek (owing to water quality concerns). Pending further assessment of water quality (which would improve with proposed habitat enhancements), the existing outlet culvert should be connected to the creek.
