**Re: Whey-ah-Wichen Shoreline Adaptation and Restoration – Invasive Species Management**

Inlailawatash Limited Partnership (Inlailawatash) has been requested by Tsleil-Waututh Nation (TWN), in consultation with the District of North Vancouver (DNV) and the Vancouver Fraser Port Authority (VFPA) to propose a workplan for ecological restoration in areas impacted by invasive plants in Whey-ah-Wichen (WAW)/Cates Park (Figure 1).

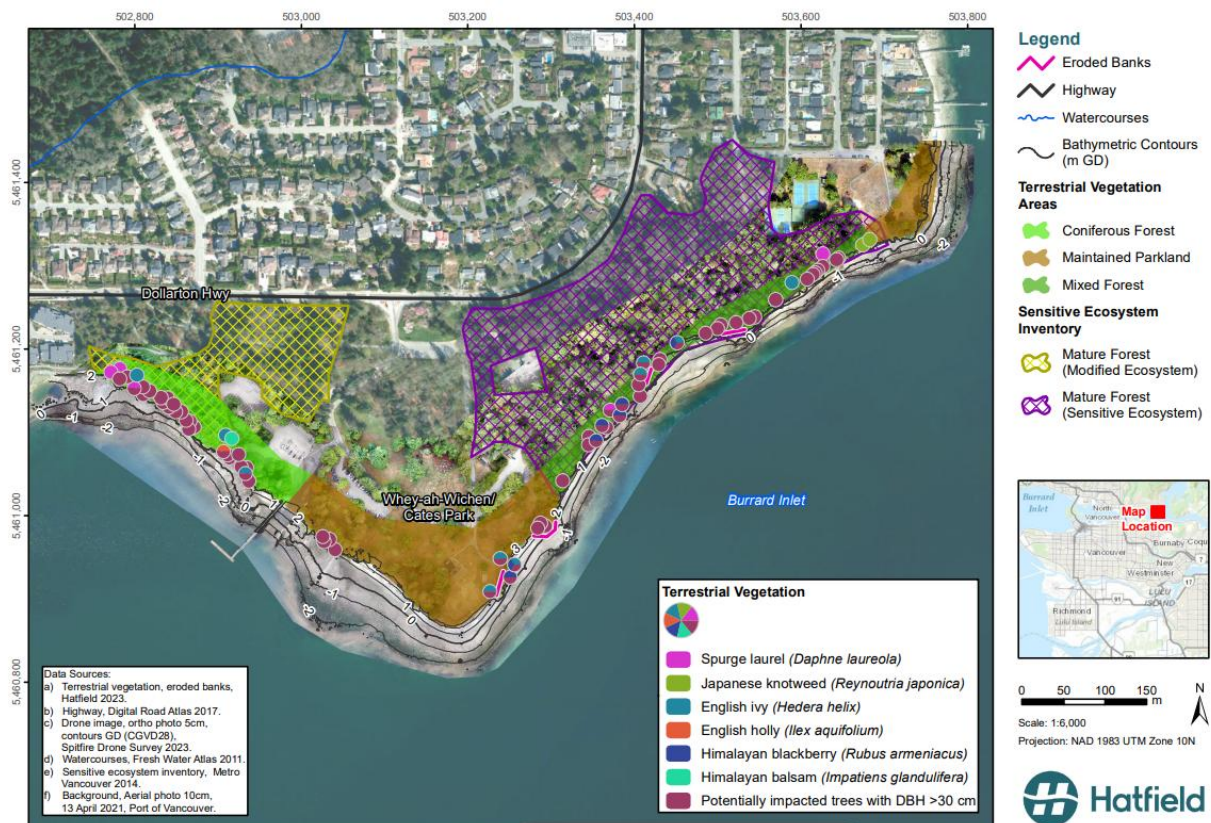
Initial invasive plant survey mapping has been completed by Hatfield consultants in 2023, this survey will be referenced and refined to reflect site conditions as of 2025 (Figure 2).

Figure 2. Invasive plant mapping on the Whey-ah-Wichen/Cates Park project area as of 2023.
